**Final Report
Pilot Project**

**Ergonomic
Assessment**

Off Road Mobile Plant

**NRG Flinders
Coal Field**

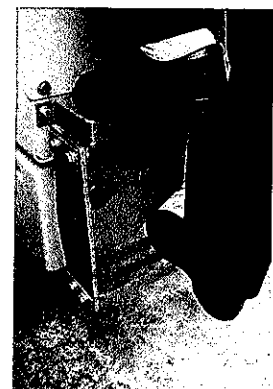
The step in figure 4 has good grip, and it is easy to clean. The rubber supports give the step some movement (so the step does not get knocked off) but it is more stable than the metal wire supports that are often used on some forms of mobile plant.

The rubber straps are effective in stabilising the step but they need to be checked regularly during maintenance to ensure they have not become ripped or dislodged from the step.

Figure 4 (above): A rubber support for the bottom step (Photo courtesy of Cavpower, SA).

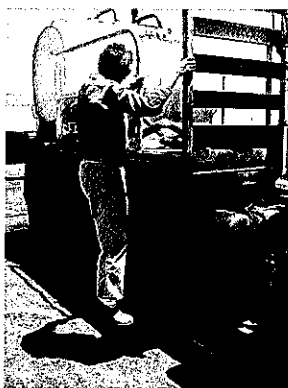
Using this step will reduce the risk of injury when climbing onto the rear of the truck because the step has the following safety benefits:

- It folds up under the platform of the truck so it does not protrude out from the side of the vehicle during travel.
- The steps are wide (550mm) which is a relatively stable width to stand on whilst climbing into and out of the rear of the plant.
- The steps are quite rigid so they provide significant stability for the person standing on the step.
- There are three rungs on the step so the bottom step is close to the ground (approximately 330mm above ground height) so it is reasonably easy to step up onto the first step.

Figure 8 (above): An extendable step on the side of the truck (Leigh Creek Coal Field, SA).

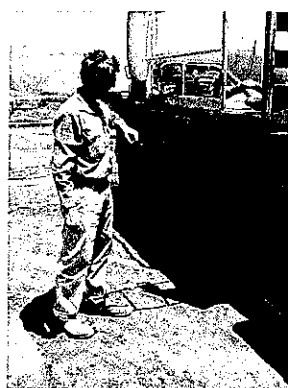
Figure 9 (above): An extendable step that can be pushed under the rear platform of the truck after it has been used. (Leigh Creek Coal Field)

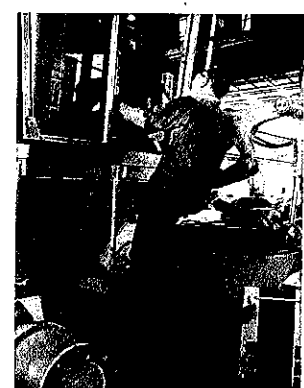
Figure 10 (above): Climbing into the cabin of the grader

The bottom step on the existing grader (CAT 16H grader) is quite high (550mm in height). Some people use the blade of the grader to stand on before climbing on the steps that lead into the cabin. The top of the blade is a thin strip of metal that does not provide adequate foot stability when the operator stands on the blade. This situation can be made more hazardous if the blade is rotated further away from the cabin causing the operator to have to reach further to move from the blade to the cabin (refer to Figure 10).

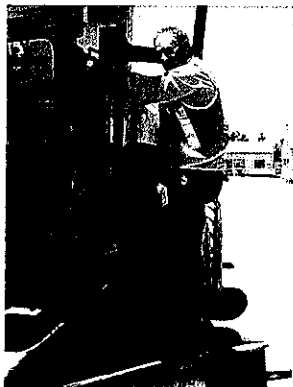
In contrast, Figure 11 illustrates how the operator's foot on the blade is in line with their body that gives them more stability.

Figure 11 (left): Climbing into a grader with the modified steps and the blade rotated back towards the cabin (One Steel, Ardrossan, SA)

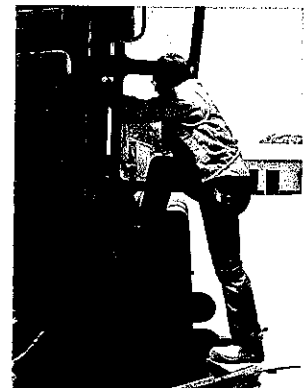
Figure 12 (right): Climbing onto a grader with the modified steps and the blade rotated away from the cabin. (One Steel, Ardrossan, SA)

Figure 12 illustrates how the operators foot on the blade is behind his body (because the blade is rotated away from the cabin which increases the distance the operator has to reach the cabin).

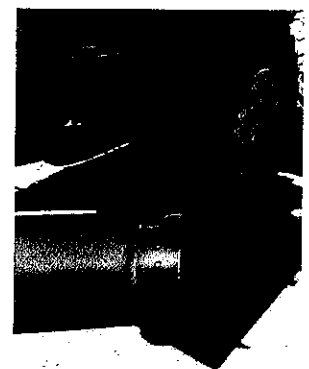
Figure 13 (below right): The modified step and footplate that have been fixed on the grader (One Steel, Ardrossan, SA).

Figure 13 illustrates how a non-slip board has been added to the blade to improve the access to the cabin (The operator must have the blade fully rotated towards the cabin).

This modification represents one option for improving the design for the access and egress from the cabin of the grader. As illustrated, this method will only be successful if the blade is rotated back towards the cabin (therefore reducing the distance the operator has to reach between the blade of the grader and the cabin door).

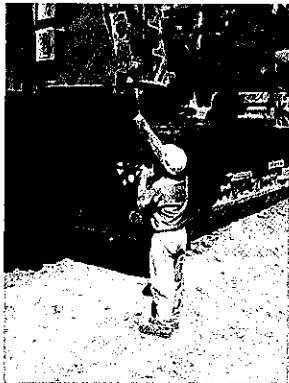
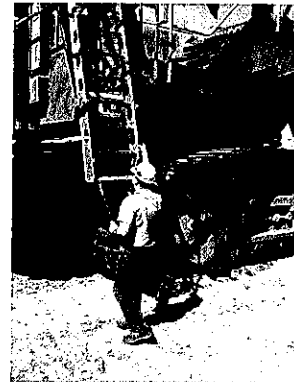
Operators are required to grasp a rope and pull down the stair for access into the crane unit. On average task is performed approximately 4-6 times per shift, although this may increase depending on the access requirements to the plant.

Figure 14 & 15 (left & right):
Reaching up to pull down the stairs.

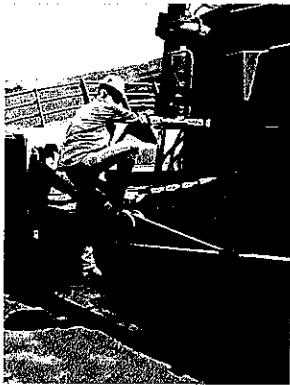
There is step access to the tracks but it does involve an extended reach by the operator whilst standing on a relatively small step (refer to Figure 17). The risks associated with this task can be increased if the operator has to carry items up onto the plant (e.g. tools, box of materials etc.). This is because the operator may lose their "3 points of contact" if they have something in their hands and therefore increase their risk of falling from the plant.

Figure 17 (left): An operator climbing up onto the tracks of the dozer so they can climb up to the cabin of the mobile plant.

The risk control recommendations for this particular hazard are quite reasonable and relatively simple to implement. These changes include adhering to safe work procedures and modifying the control on the platform lifter.

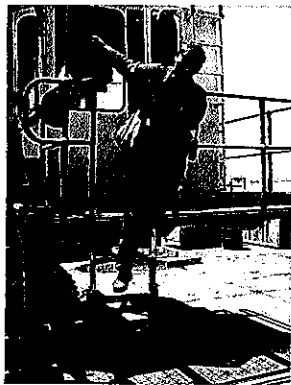
There is less opportunity to control the speed and movement when stepping down onto the ground when the operator uses the egress method illustrated in Figure 19. This is a significant problem for all forms of mobile plant that have vertical steps. This problem is further exaggerated if the person jumps from the bottom step. Their lack of control of movement may increase the risk of twisting an ankle on a rock on the ground or sustain an injury through a high force impact on unstable ground.

Figure 19 (above): A mechanic climbing down from a drill rig².

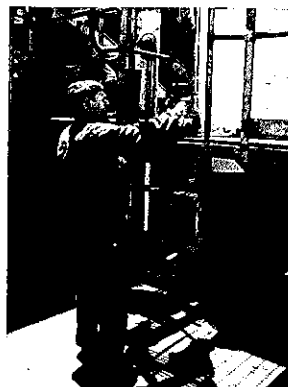
Figure 20 (below) operator climbing up onto a drill rig

Figure 20 illustrates an example where a mechanic has lifted some tools onto the drill rig platform. After this the operator climbs onto the platform unencumbered rather than trying to climb up the rig whilst carrying the tools and climbing at the same time.

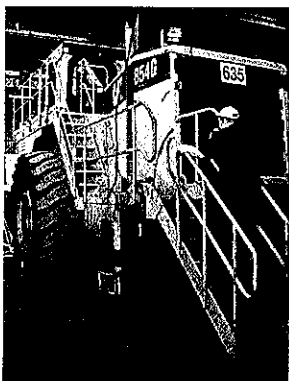
Many pieces of plant have very good access and egress requirements for operators to reach the cabin of the plant. The CAT 854G rubber tyre Dozer illustrates a reasonable set of steps and rails on one side of the plant.

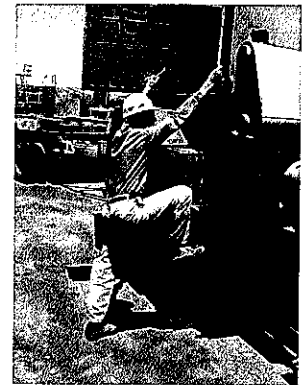
The bottom step and handles are quite high. The bottom step is approximately 500mm above ground height and the top handrail is approximately 1,900mm above ground height. Taller operators maybe able to reach this but shorter people will put additional strain on their shoulders and knees, as they have to climb up into the cabin.

Figure 27 (above):
Climbing into the
cabin of a truck

The right hand vertical handrail (illustrated in Figure 27) could be extended down approximately 30cm. This will reduce the extended range of movement with the right shoulder and make it safer for people (especially shorter people) to climb into the cabin. If this change alone is not satisfactory, a lower handle on the left hand side of the cabin entry can be introduced.

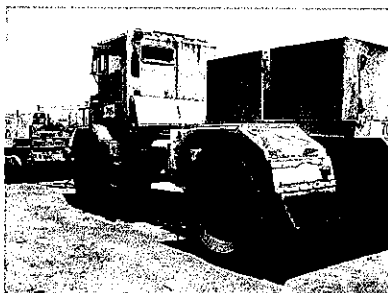
Figure 28 (left): The truck that
requires the handle modifications
to the cabin entry.

Figure 29 (right): Handles a
significant distance apart for the
operator climbing into the cabin.

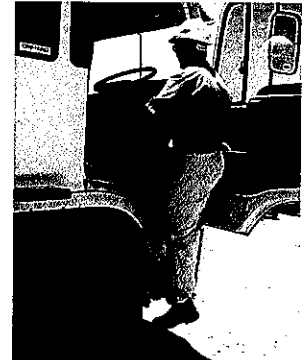
The left hand handles for climbing into the cabin are inside of the doorway, and not outside the cabin (like the cabin in Figure 24). This means the operators arms are not so extended out to the side as much when they climb into the cabin. This significantly reduces the strain placed on the shoulders during this task. The left hand handle has a curved shape so different operators (who have different arm lengths) can choose the most comfortable hand position for climbing into the cabin.

Figure 30 (above):
Different handles for
the Hino truck

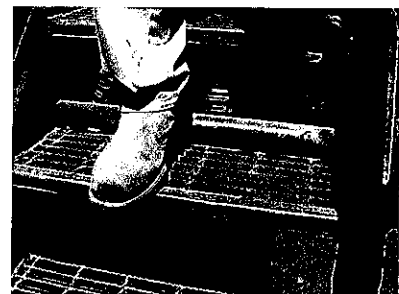
Figure 31 (above): The steps
on a P & H crane

If the steps are broken or the grips are worn or missing from the plant these environmental factors can further increase the risk of injury for people climbing on the plant.
