**Demonstration and Proving of the “Acoustic Energy  
Meter” for Detecting Incompetent Mine Roof as Part of  
Routine Roof Sounding**

August 2004

Report No: 00-001-AEM-01

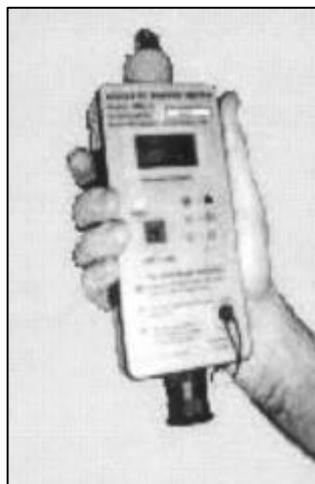
The current model AEM is the RDL4, built by Rock Mechanics Technologies Ltd (RMT) in England. The RDL4 utilises a transducer which can be placed in contact with the surface of the medium (rock), a prescribed method of striking the surface close to the transducer (hammer, steel rod etc.) and a detector (geophone). It also has automatic arming and reset functions and features a “traffic light” LED alarm display, as well as a digital readout. A picture of the RDL4 is given in **Figure 2.2**.

**Figure 2.2. RDL4 Acoustic Energy Meter**

The operation of the AEM requires holding the geophone to the rock surface, either directly or through the use of an extension pole. The surface is then struck with a hammer or equivalent within 0.2m to 0.5m of the geophone and a reading is illuminated on the digital display. A minimum of three readings is usually taken for each sample point then, averaged.
