Managing whole-body vibration associated with underground coal mining equipment

Coal Services Health and Safety Trust project 20643
Final report

Danellie Lynas
Robin Burgess-Limerick

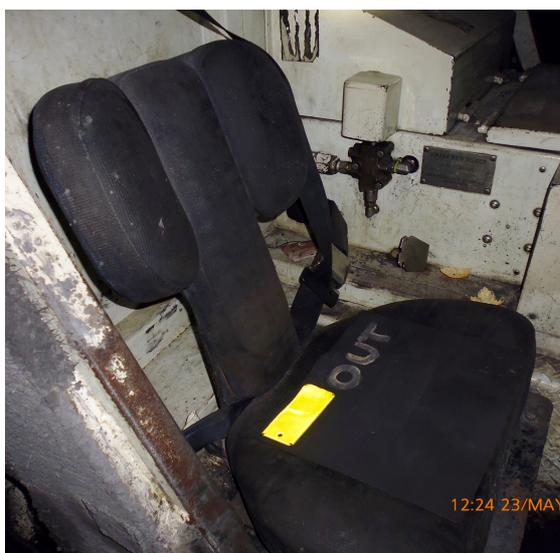
Each iPod Touch was secured in a pocket sewn onto a neoprene square (350 mm). A reflective label was attached to one corner of each neoprene square which allowed iPod trial identifying information to be attached. Prior to each shift commencement, operators received individual instruction on how and where to place the neoprene square so that the iPod was located lengthways under the ischial tuberosities of the operator once seated (Figure 1). The device was returned at the end of each shift for data retrieval. Whilst there is potential for operator error in iPod placement, subsequent data inspection indicated data patterns recorded to be consistent with that expected during respective equipment operation.

Figure 1: iPod placement on the seat of transport vehicle.

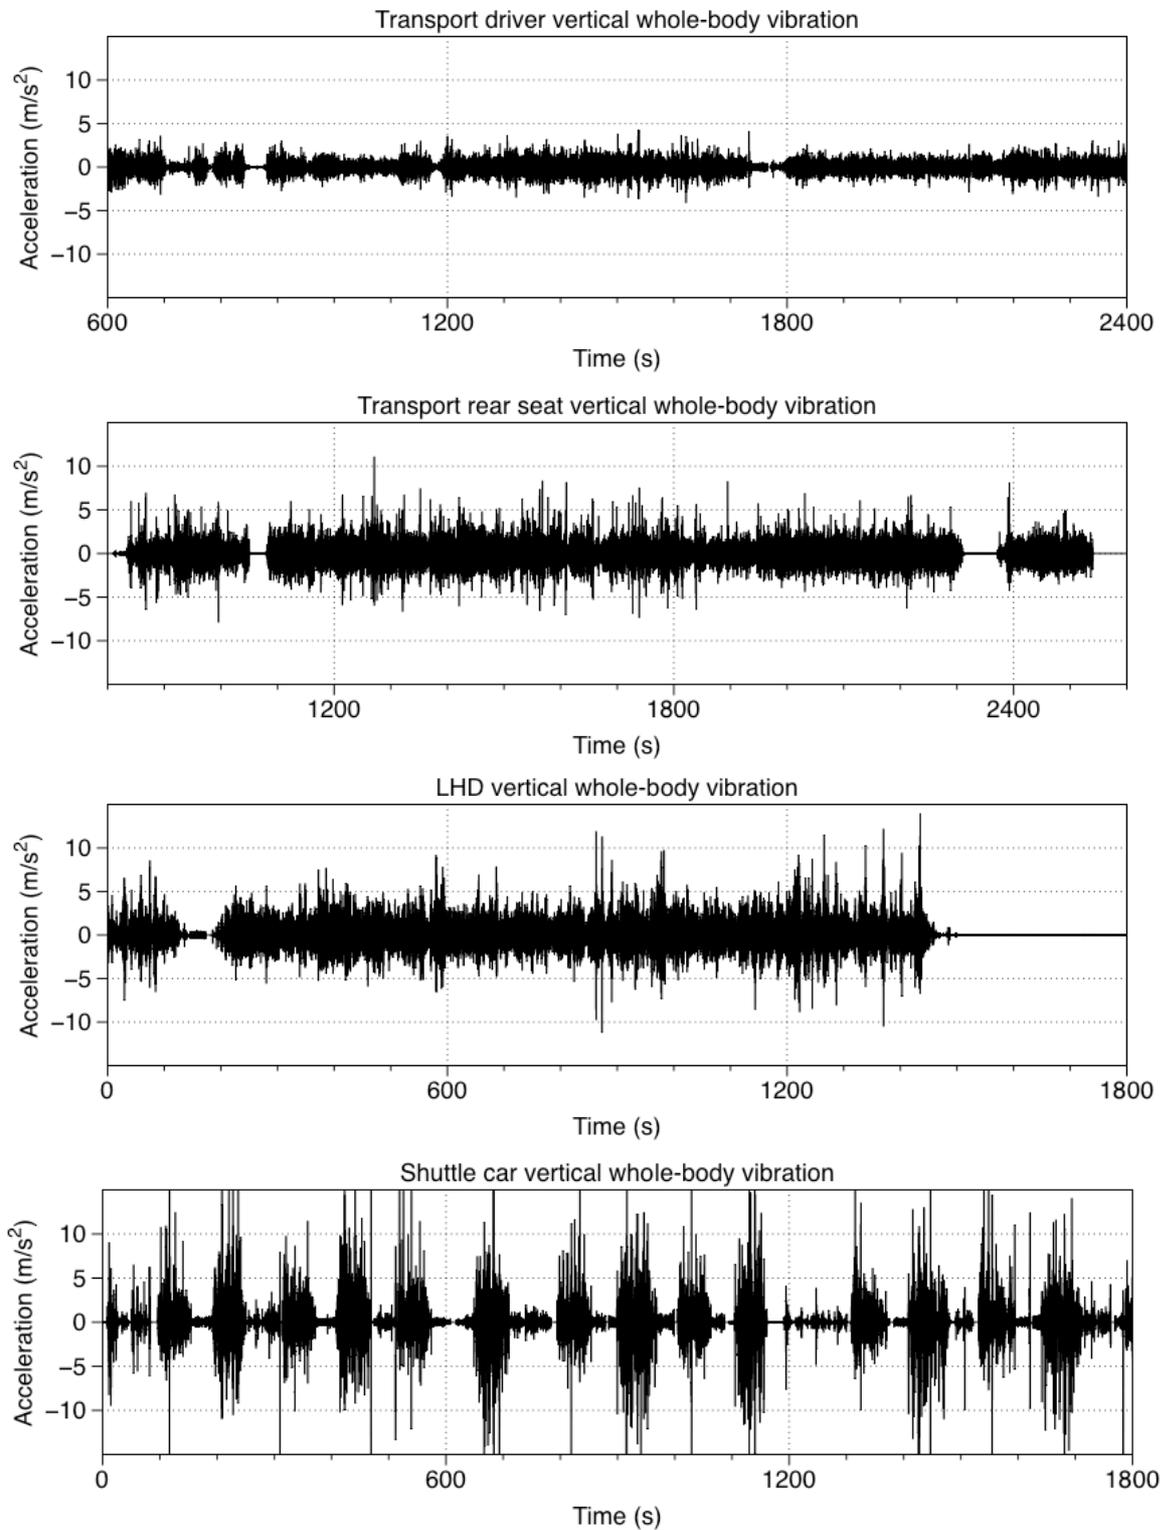
Figure 2 illustrates typical frequency weighted vertical whole-body vibration recordings obtained from a range of underground coal mine mobile plant. The corresponding frequency spectra are illustrated in Figure 3.

Figure 2: Frequency weighted vertical whole-body vibration samples taken from a range of underground coal mining equipment.

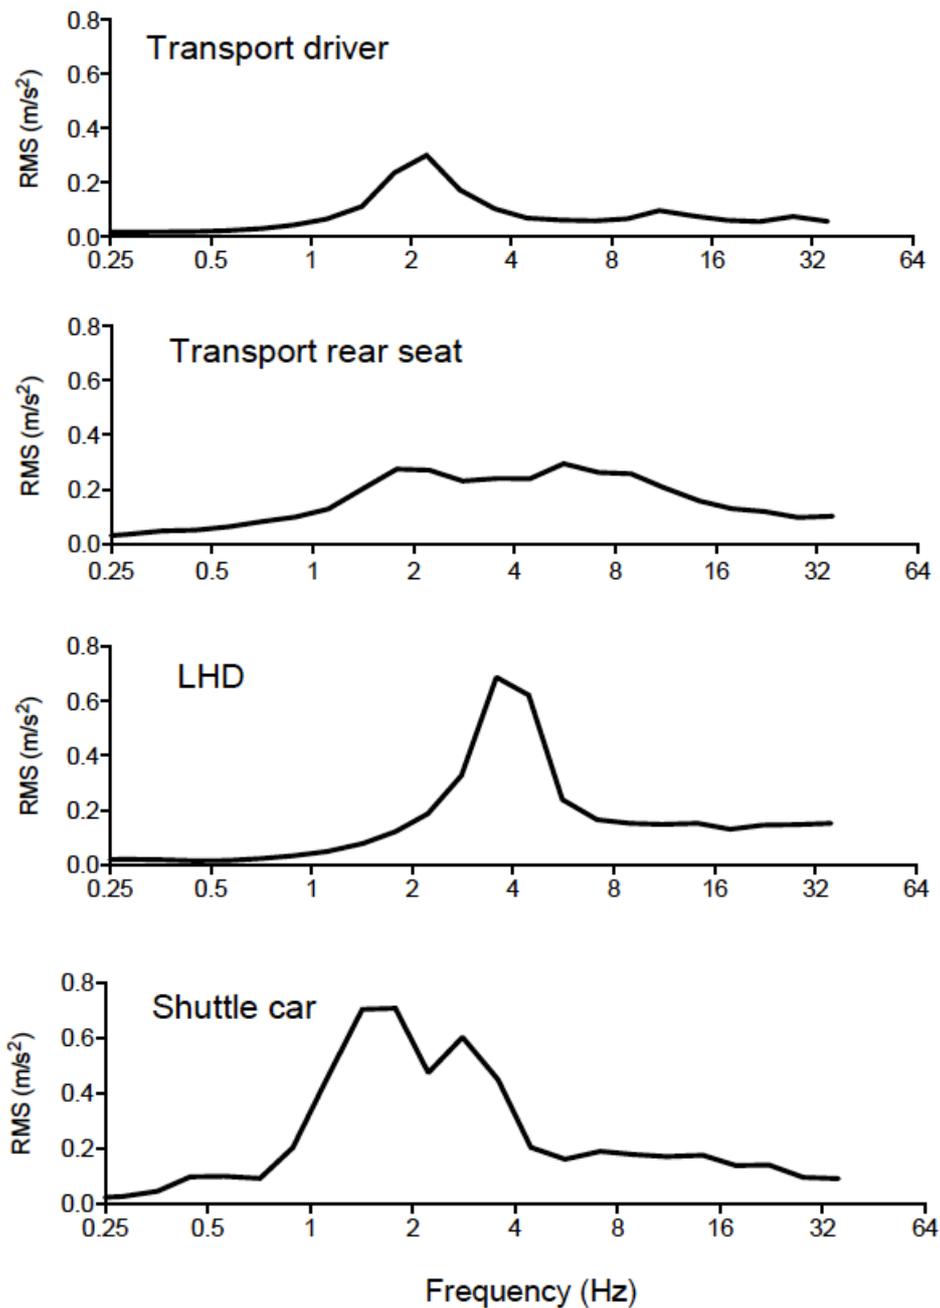
Figure 3: Frequency spectra for vertical whole-body acceleration measurements taken from a range of underground coal mining equipment.

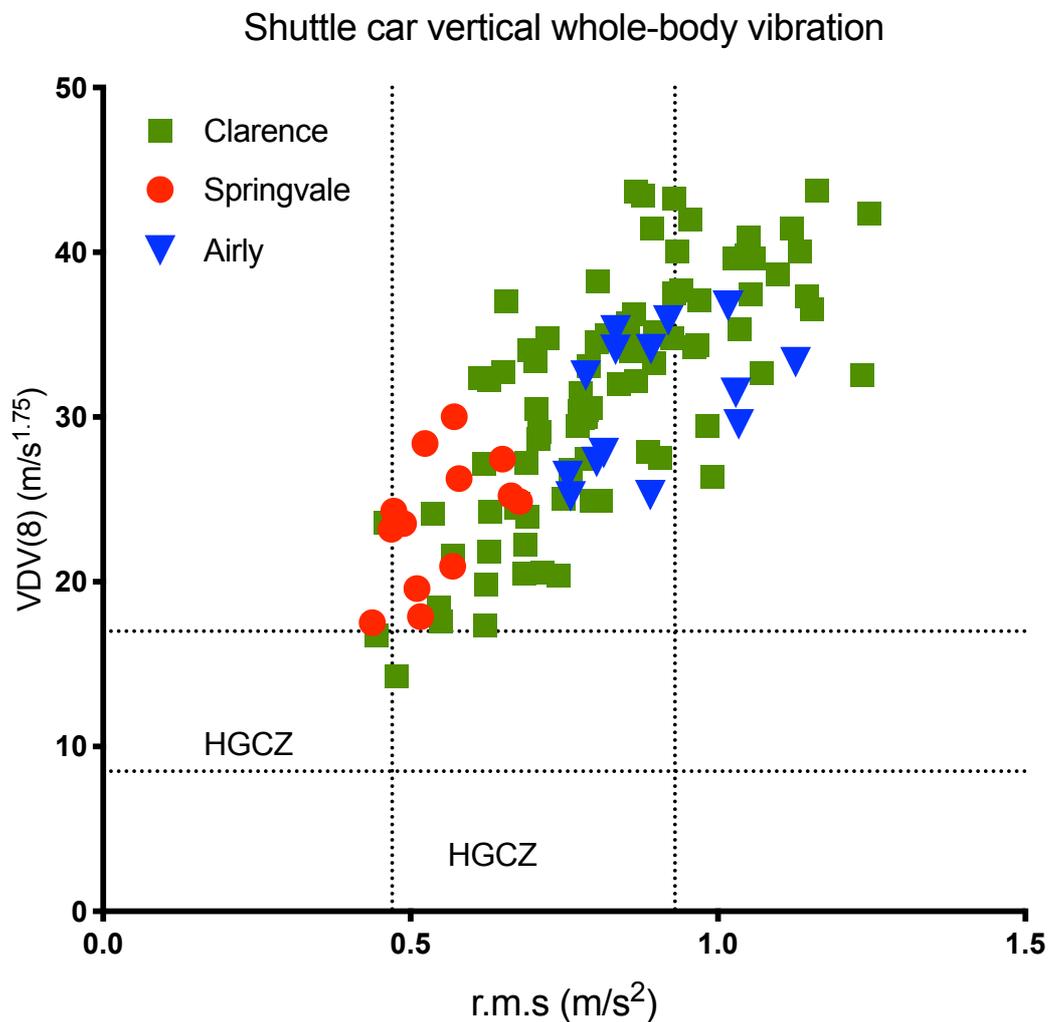
Shuttle cars were identified as requiring more detailed examination. Figure 4 illustrates the vertical whole-body vibration measurements obtained from shuttle cars operating at each site during 2017-2019 visits. Considerable variability was evident, however the measurements indicated high amplitudes of whole-body vibration with all except two measurements exceeding the ISO 2631.1 Health Guidance Caution Zone for both VDV(8) and r.m.s. The average r.m.s and VDV(8) shuttle car measurements obtained for each site were 0.90 m/s², 0.83 m/s², 0.55 m/s² and 31.44 m/s^{1.75}, 31.55 m/s^{1.75}, 23.78 m/s^{1.75}, for Airly, Clarence and Springvale site respectively.

Figure 4: Vertical whole-body vibration measurements taken from shuttle cars at three underground coal mines. The data are expressed as VDV(8) and r.m.s. with respect to the ISO2631.1 Health Guidance Caution Zone (HG CZ) for an 8 hour daily exposure.

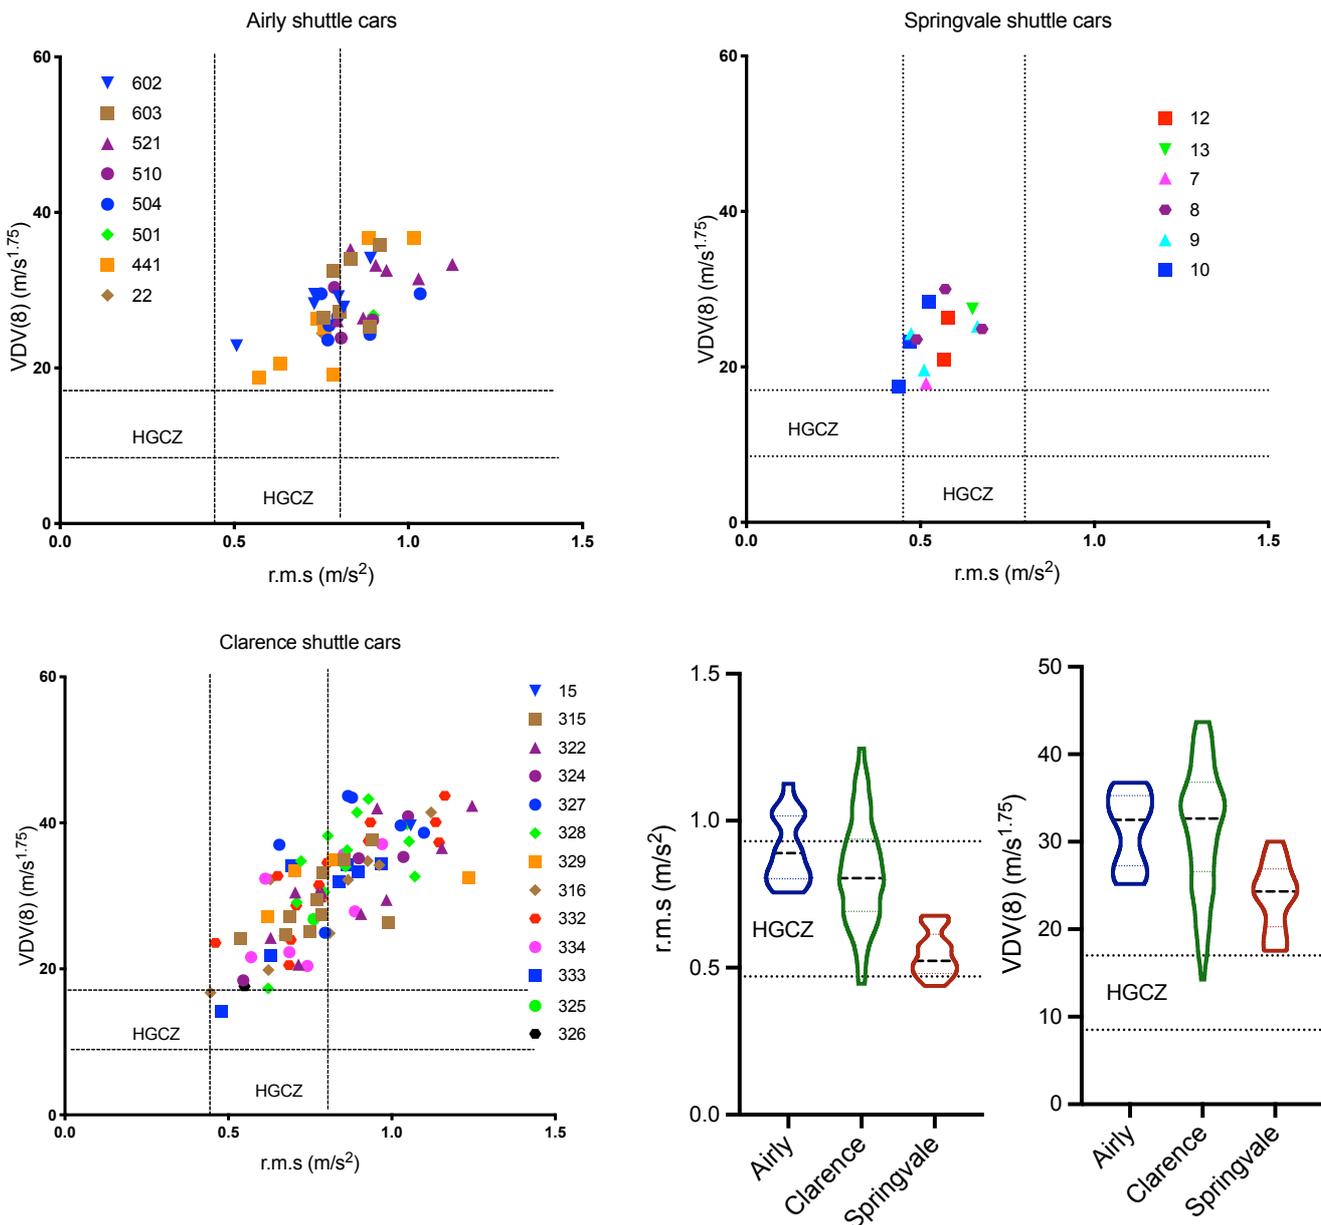
Figure 5 illustrates shuttle car data from each site by individual cars. The range of values recorded from individual shuttle cars appears to be large. The differences observed between sites are likely to be a consequence of different mining methods (longwall vs place change) which in turn influences roadway conditions, wheeling distances, wait time, and the number of trips each car makes per shift. Other influencing factors accounting for the variability of measurements from a single car include the condition and adjustability of the seat mechanism (including driver knowledge of appropriate adjustment); tyre composition/suspension of each car; roadway conditions over which the cars are operating; and the behaviour of the operator.

Figure 5: Vertical whole-body vibration measurements taken from shuttle cars at three underground coal mines for individual shuttle cars. The data are expressed as VDV(8) and r.m.s. with respect to the ISO2631.1 Health Guidance Caution Zone (HGCZ) for an 8 hour daily exposure.

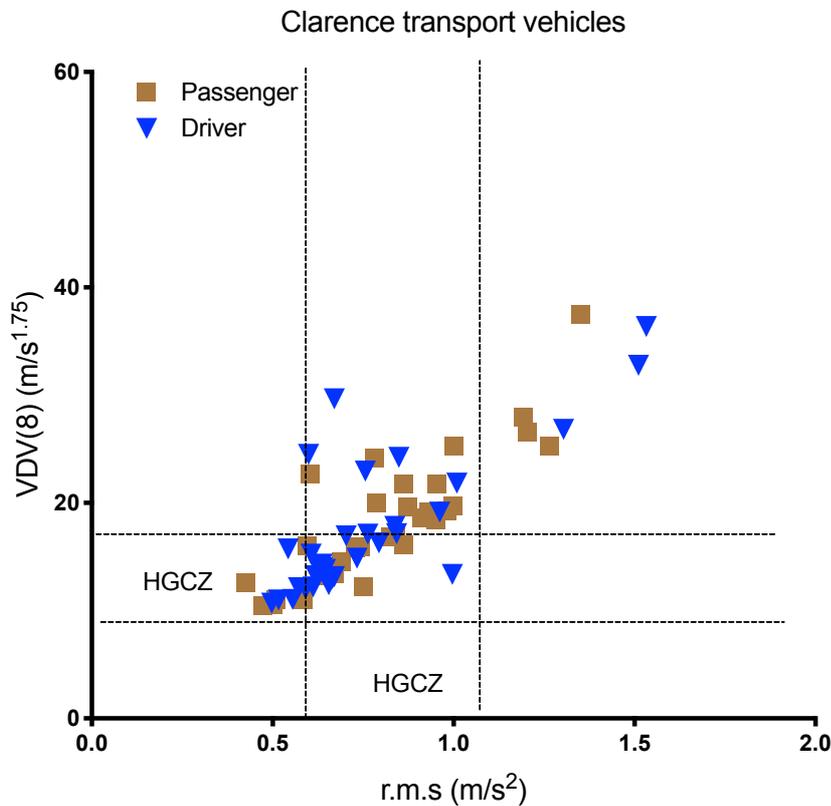
Figure 6 illustrates personnel transport vehicle data obtained during Clarence site visits in 2017-2018 from driver and rear seat passenger travelling the main access road. Whilst travel time is relatively short, all measurements fall either within the Health Guidance Caution Zone (HGCZ) or above for both VDV(8) and r.m.s. values, suggesting that attention to these exposures is justified. To investigate this further, a number of measurements were subsequently taken from both from and rear seat positions in SMV and PJB vehicles. For example, during 2019 two site visits to Clarence mine yielded 34 paired driver and passenger measurements for travel into and out of the mine, aligning the vehicle measurements with roadway maintenance activity. These, and other measurements taken at both Clarence and Airly sites to investigate the effects of vehicle speed and roadway conditions on whole-body vibration exposures are discussed in further detail in the second section of this report.

Figure 6: Vertical whole-body vibration measurements taken from personnel transport vehicles (SMV/PJB) at Clarence underground coal mine. The data are provided for driver and passenger and expressed as VDV(8) and r.m.s. with respect to the ISO2631.1 Health Guidance Caution Zone (HGCZ) for an 8 hour daily exposure.

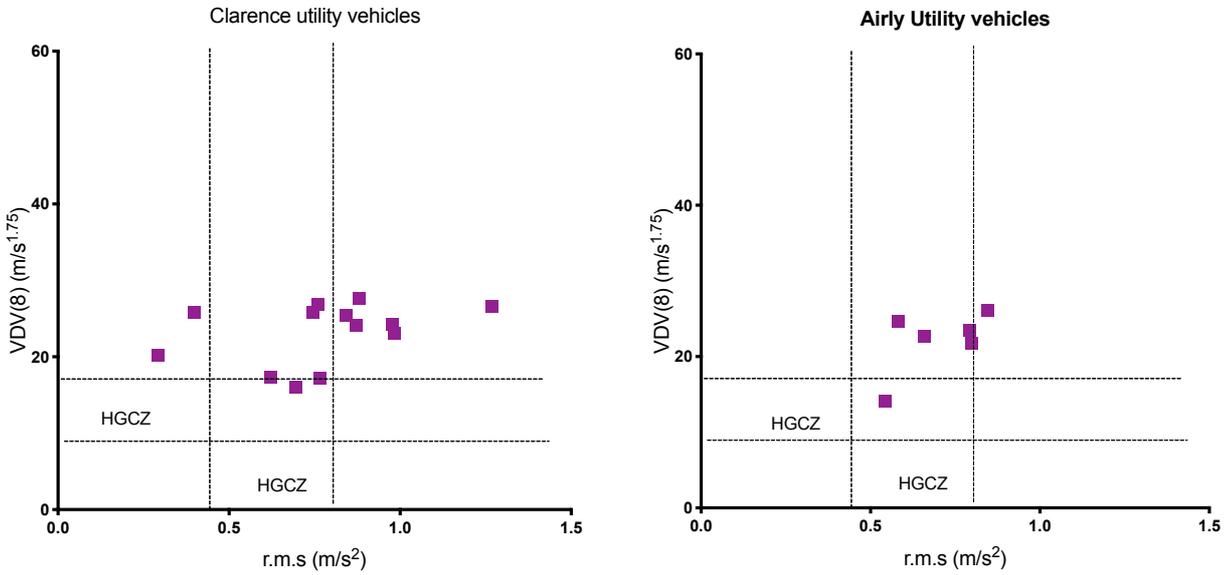
Figure 7 illustrates utility vehicle (primarily materials transport) data obtained from Clarence and Airly sites. The majority of measurements recorded from both sites, for both VDV(8) and r.m.s. lie above the upper limits of the Health Guidance Caution Zone. Utility vehicles undertake a number of tasks during a shift and may be operated with different attachments depending on task requirements (e.g. duck bill, bolt pods, road leveller, cable reel, gravel trailer) and may be travelling with a full or empty bucket. While collecting measurements from these vehicles (EIMCO, LHD, coal tram) at Clarence site additional data collection relating to the tasks undertaken during the shift was sought (e.g. information on roadway condition; seat condition and adjustability; travel distances), unfortunately not all operators provided this information which prevented further analysis. Figure 8 provides a comparison between personnel and supply vehicle VDV(8) and r.m.s. from data obtained during visits to Clarence mine site in 2018. All vehicles demonstrated measurements exceeding the HGCZ for both VDV(8) and r.m.s., confirming both personnel and utility vehicles are sources of operator exposures in excess of the HGCZ and deserving of the implementation of control measures to reduce these exposure levels.

Figure 7: Vertical whole-body vibration measurements taken from utility vehicles (LHD's) at Clarence and Airly mines. The data are expressed as VDV(8) and r.m.s. with respect to the ISO2631.1 Health Guidance Caution Zone (HGCZ) for an 8 hour daily exposure.

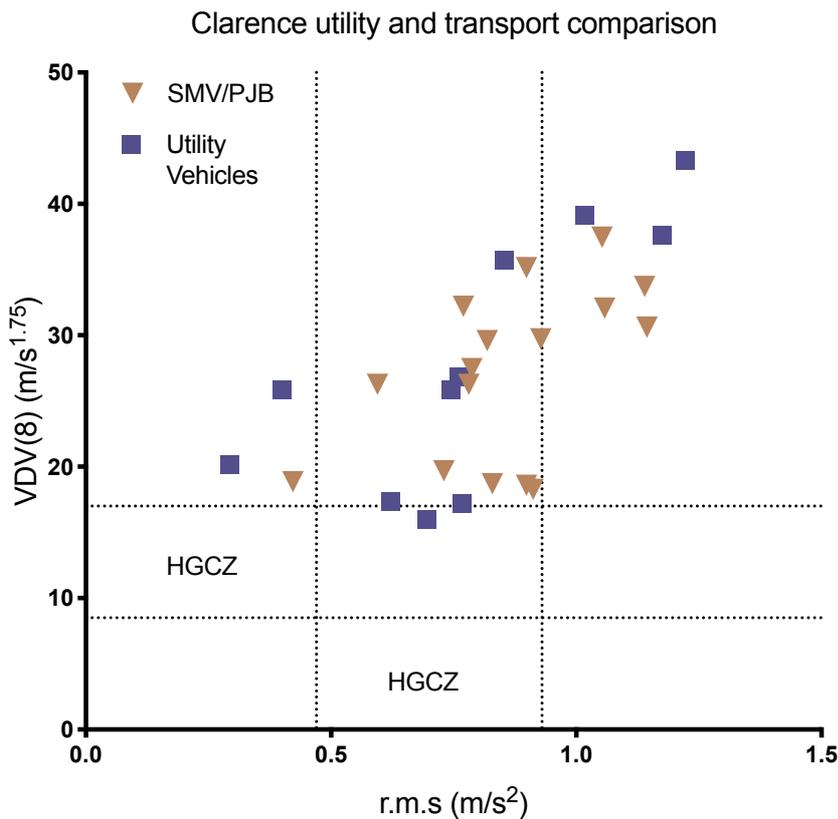
Figure 8: Comparison vertical whole-body vibration measurements taken from personnel and supply vehicles at Clarence mine. The data are expressed as VDV(8) and r.m.s. with respect to ISO2632.1 Health Guidance Caution Zone (HGCZ) for an 8hour daily exposure.

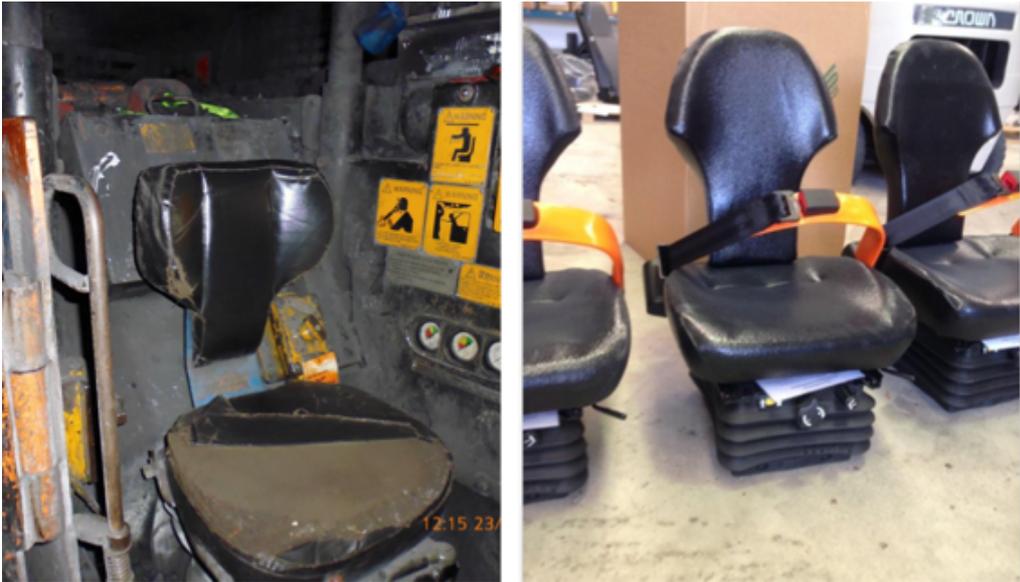
In late 2017, the worn seats in shuttle car 324 were replaced with new Sears seats. (Figure 9 shows seat condition before and new replacement seats). In 2018, a second shuttle car (SC 325) was refurbished and the seats were replaced with KAB seats. Whole-body vibration measurements were recorded before and after seat replacement. Floor and seat measurements were also obtained during two shifts from shuttle car 325 prior to seat replacement. The vertical r.m.s. SEAT measurements obtained were 1.08 and 0.97, indicating that the worn seat was providing little, if any, attenuation of vertical whole-body vibration.

Figure 9: Seat condition before replacement and new seats awaiting installation.

The effect of replacing worn shuttle car seats with new seats was evaluated at Clarence. Two of shuttle cars were fitted with new seats (one KAB the other Sears). Seat design, condition and adjustment is known to influence operator whole-body vibration exposure levels (Blood et.al, 2010; Paddan & Griffin, 2002). However, seat installation needs to suit both the vehicle and its operating environment, and performance differences across seats may have significant health implications for drivers and equipment operators (Blood et.at, 2010). Weight adjustability is often incorporated in seat design and manufacture, which implies a manual adjustment that is often overlooked in practice on site, or confused with height adjustment. Appropriate seat adjustment requires operator understanding of, and training in, how to correctly adjust the seat, and automatic weight sensing and adjustment is more likely to be effective in vibration attenuation.

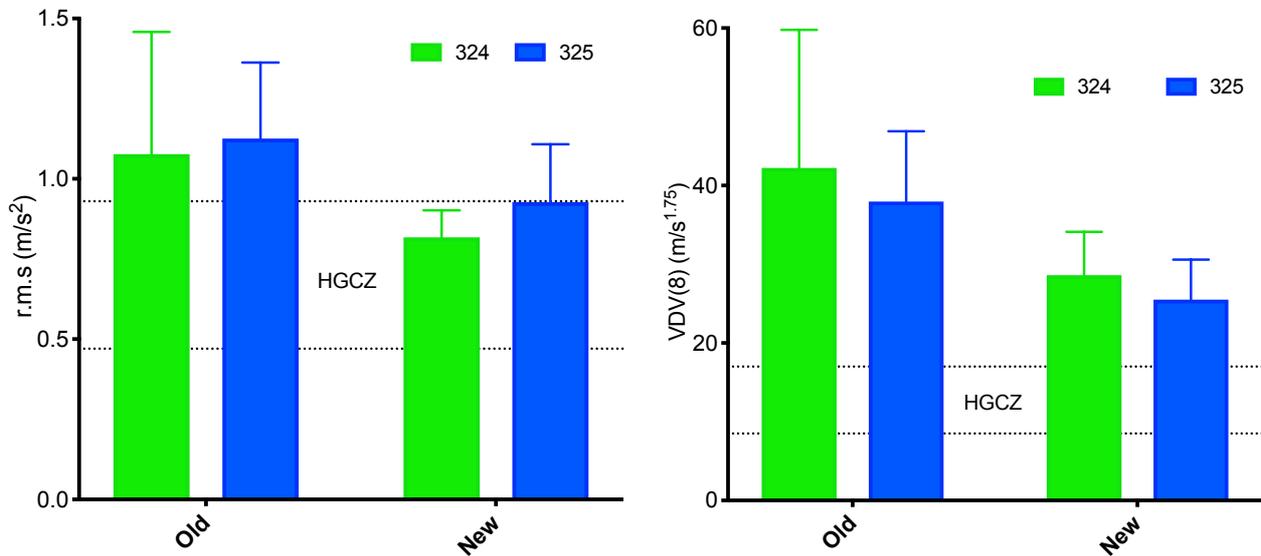
Figure 10 illustrates VDV(8) and r.m.s. vertical whole-body vibration values obtained from the two shuttle cars following new seat installation (N=9) compared to values observed with the old seats (N=7). While the small number of measurements precluded meaningful statistical comparison, the vertical whole-body vibration amplitudes measured after the change were lower for both shuttle cars. The average reduction in r.m.s. and VDV(8) amplitudes across both cars was 0.12 m/s² r.m.s. and 6.34 m/s^{1.75} VDV(8) which represents a meaningful improvement.

Figure 10: r.m.s. (left panel) and VDV(8) (right panel) vertical whole-body vibration measurements from two shuttle cars before and after seat replacement (mean and SD).

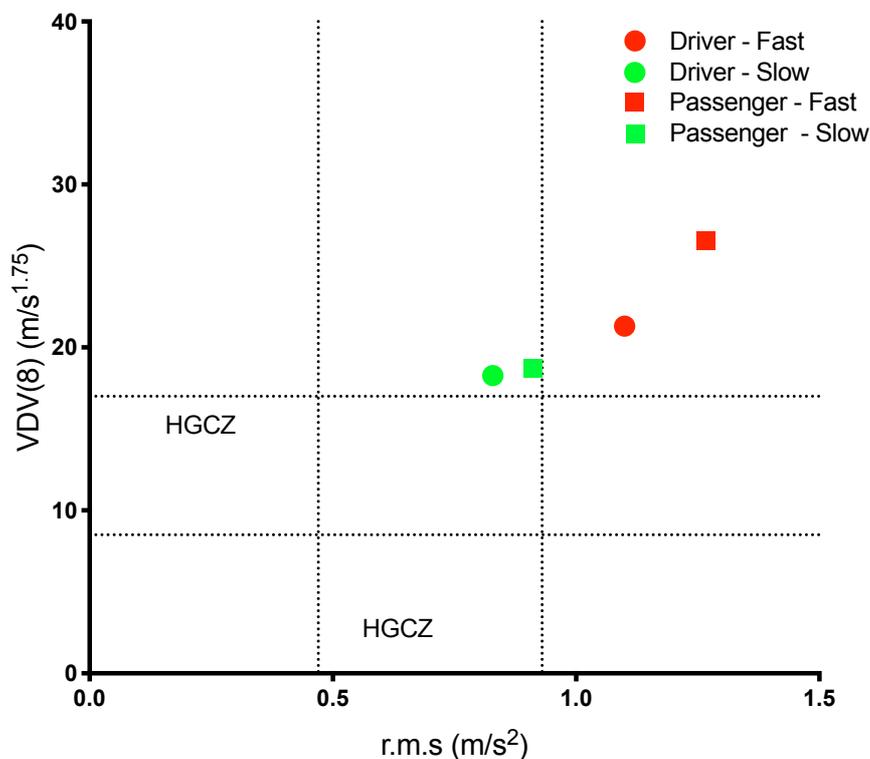
To investigate further the effect of vehicle speed on whole-body vibration exposure levels, the iPod touch devices were used to gather measurements from the driver and front seat passenger of an SMV personnel transport vehicle traversing the same section of the main access road at 2 different speeds (Figure 11). The vehicle's speedometer was not functioning and the experienced driver estimated the speed of vehicle, driving the vehicle either: (i) "flat out" at a speed reflecting the vehicle driven as fast as it would normally be driven or (ii) at a slowest speed (approximately 5 km/h). Slightly higher r.m.s and VDV(8) amplitudes were recorded for the passenger than for the driver at the slowest speed, however the difference was greatly magnified at the higher speed indicating the difference in seating provided for driver and front passenger.

Figure 11: Vertical whole-body vibration amplitude for SMV driver and front passenger at slow and fast vehicle speeds.

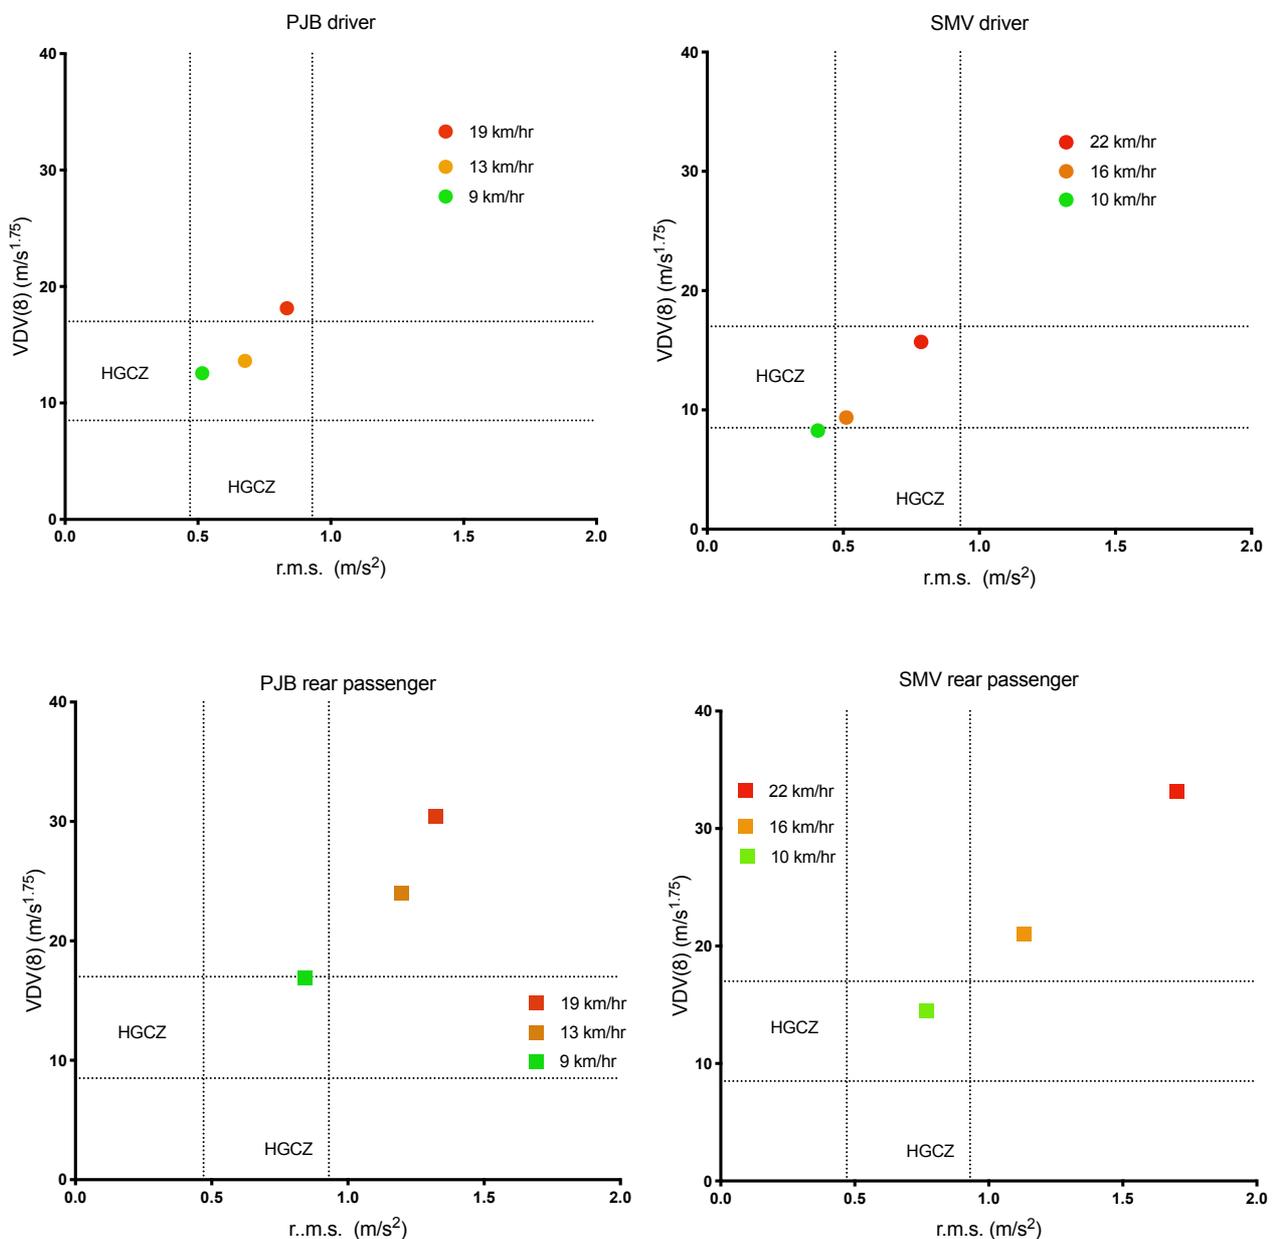
iPods were placed under the driver of the vehicle and a passenger seated in the rearmost seat. This position, located behind the rear suspension of the vehicle, is known to offer the roughest ride in both types of personnel transport vehicles. Figure 12 illustrates vertical VDV(8) and r.m.s. values for both the driver and rear passenger in PJB R510 and SMV 502 vehicles for the three different speeds.

Figure 12: Vertical whole-body vibration amplitude for SMV and PJB driver and rear passenger at slow and fast transport vehicle speeds.

The effect of increasing vehicle speed on increasing vertical vibration amplitudes was consistent regardless of seating position, however while the values measured at the driver's seat for both vehicles was largely within the ISO2631.1 health guidance caution zone regardless of speed, the effect on the rear passenger was much greater, and the vertical vibration measurements well exceeded the HGCZ for speeds greater than 10 km/hr, and were extremely high for the highest speeds.

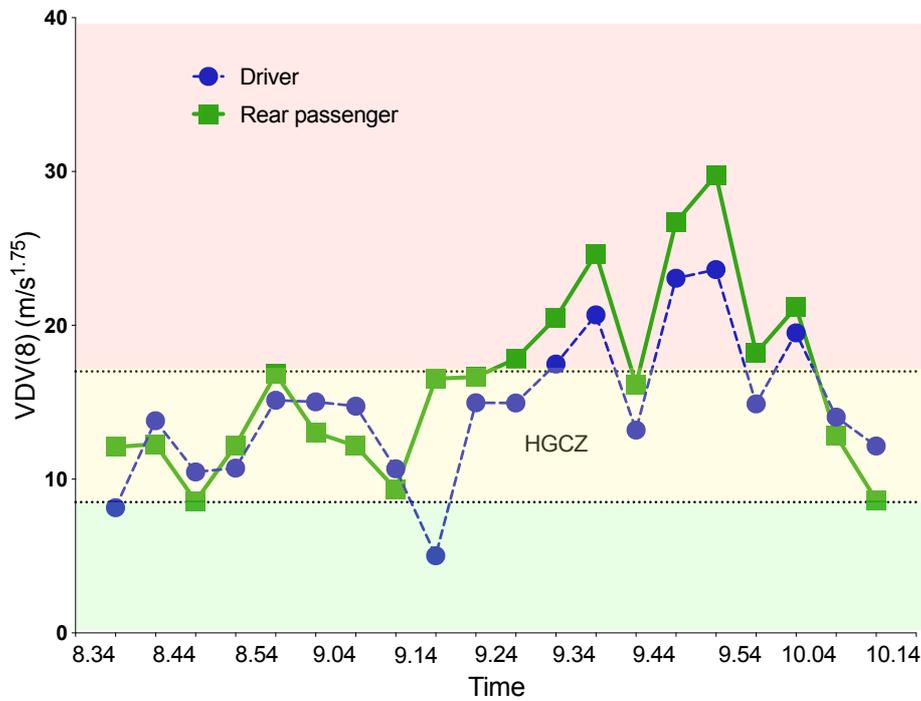
Measurements were obtained at 5-minute intervals from driver and passenger seat positions as the vehicle travelled from the diesel bay pit bottom to an operating panel via the main travel road. The VDV(8) measurements for the first 30 minutes of the journey lie largely towards the higher end of the HGCZ as defined in ISO 2631.1 with measurements taken towards the end of travel significantly exceeding the HGCZ limits. VDV(8) measurements are higher for the rear seat passenger than the driver. Figure 13 illustrates the vertical vibration amplitude expressed as VDV(8) for the vehicle journey leaving pit bottom to turning onto the main travel road. The recorded values of the measurements corresponded with the description of roadway conditions on the main travel road as outlined in a previously prepared workplace inspection report. The report indicated severe pothole damage requiring immediate attention.

Figure 13: Vertical whole-body vibration amplitude for SMV driver and front passenger at 5 minute intervals during for driver and rear passenger while navigating the main travel road.

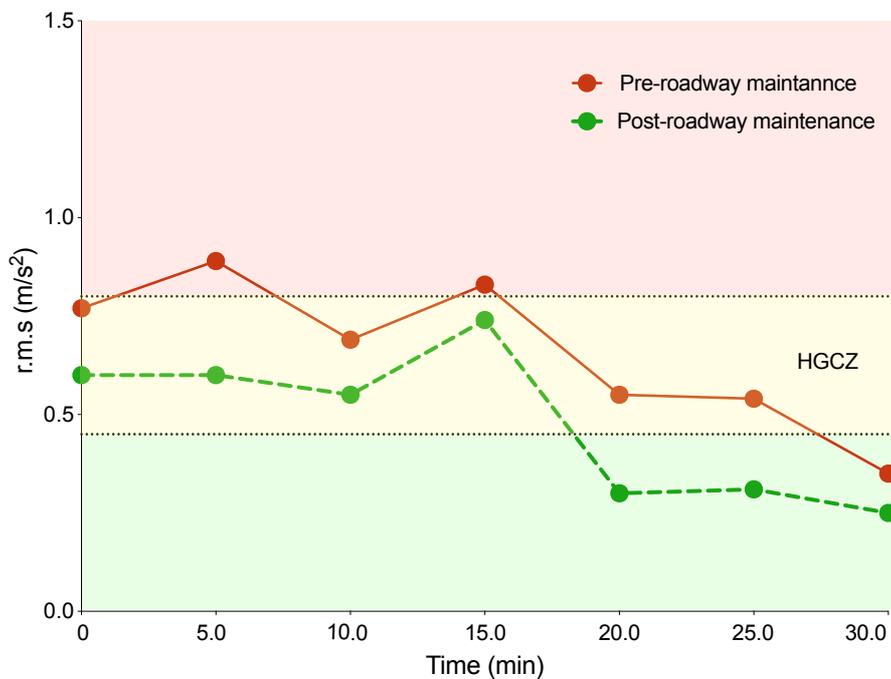
The whole-body vibration measurements were repeated following maintenance of the roadway section identified as requiring attention. The driver, vehicle and travel route remained the same. Figure 14 illustrates r.m.s. values for the driver for a 30 minute section of the trip from leaving end of one of the panels and to returning to diesel bay at the pit bottom. The average decrease in vertical whole body vibration amplitude for the driver was 0.195 m/s² r.m.s which is a substantial improvement.

Figure 14: Vertical whole-body vibration amplitude for SMV driver at 5 minute intervals for the same section of roadway before and after maintenance.

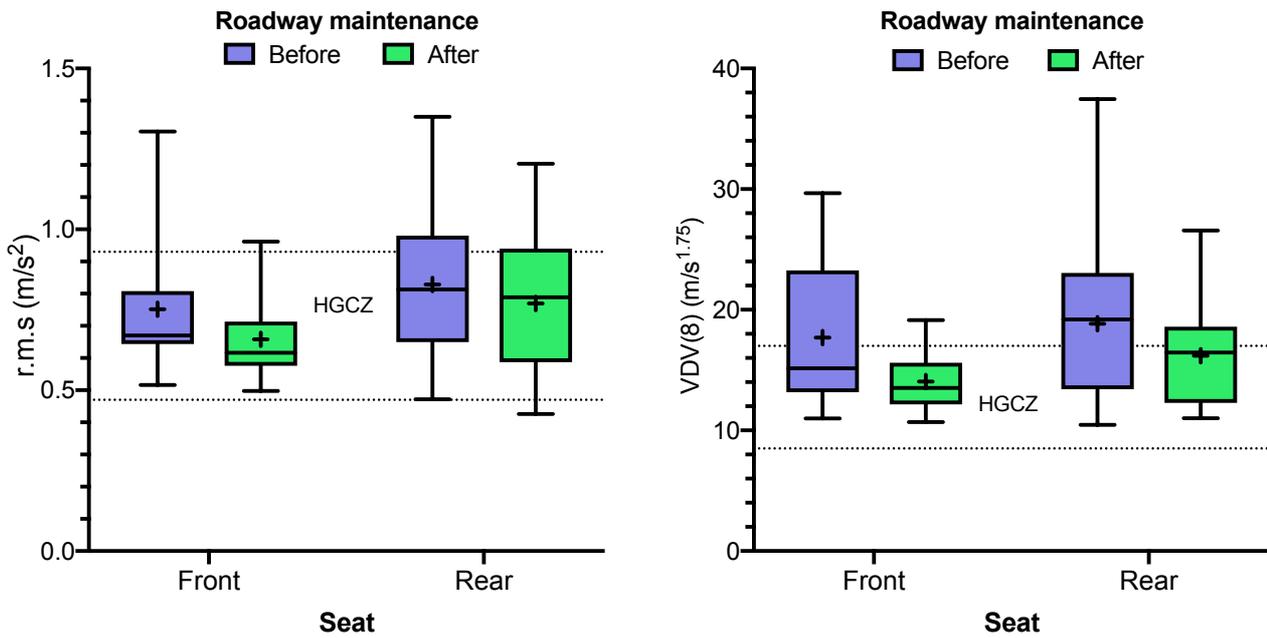
Further measurements of transport driver and passenger whole-body vibration before and after roadway maintenance were obtained from the main travel road at Clarence in 2019. Twenty-six measurements were obtained from the driver's seat, and 16 measurements were obtained from rear passenger seats during normal operations over a six day period prior to roadway maintenance being undertaken by the site. A further 18 measurements were obtained from the driver's seat, and 12 from rear passenger seats, over a five day period following roadway maintenance. Figure 16 illustrates the impact of roadway maintenance on vertical whole-body vibration amplitude expressed as r.m.s and VDV(9) for driver (front) and rear seat passengers. The average reduction in vertical whole-body vibration amplitude measured for the driver's seats was 0.093 m/s² r.m.s, and 3.6 m/s^{1.75} VDV(8). The average reduction in measured for the rear passenger seats was 0.059 m/s² r.m.s, and 2.6 m/s^{1.75} VDV(8).

Figure 15: Vertical whole-body vibration amplitude for SMV driver at 5 minute intervals for the same section of roadway before and after maintenance.
