### **Investigation of Feather Edging Caving and Bolted Breakerlines in Split and Lift Pillar Extraction at Blue Mountains Colliery, NSW**

Investigation of feather edge caving and bolted breakerlines  
in split and lift pillar extraction at Blue Mountains Colliery,  
NSW

SMG 610/1

18 November, 1998

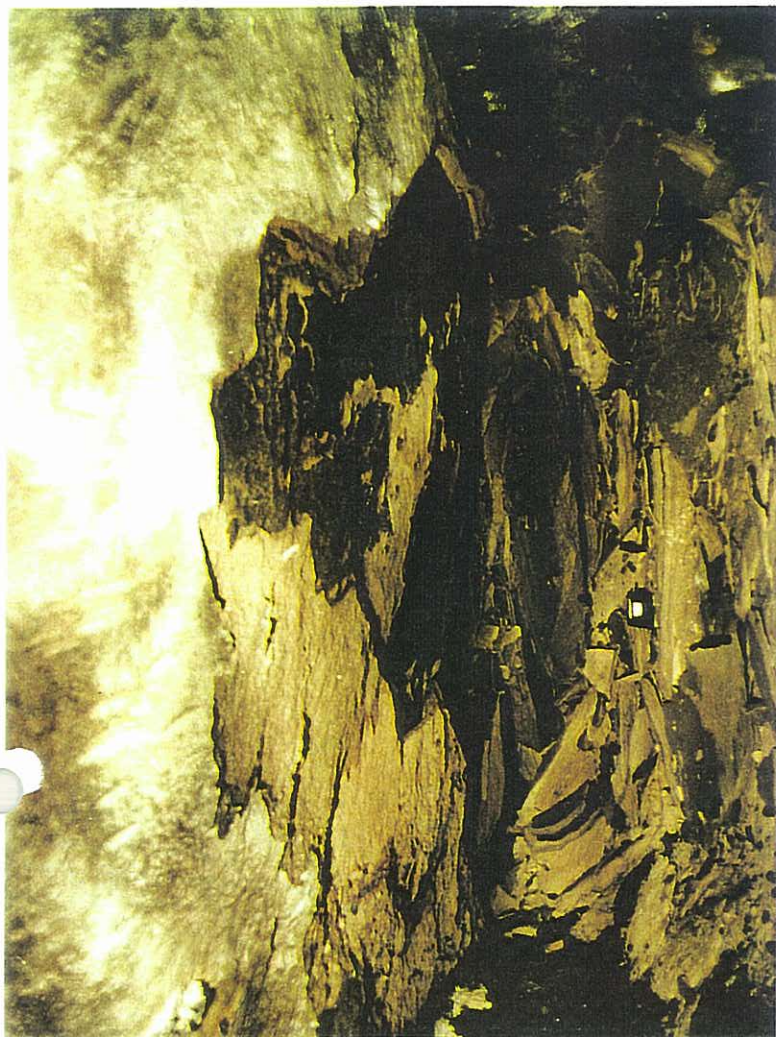
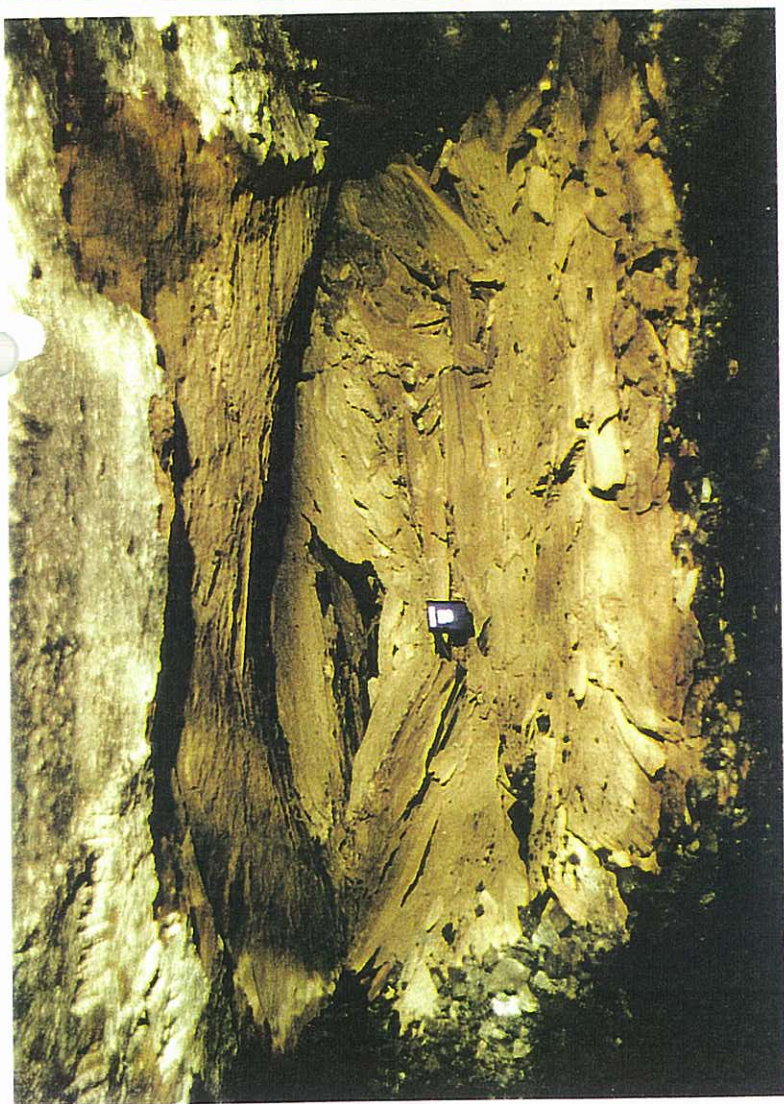
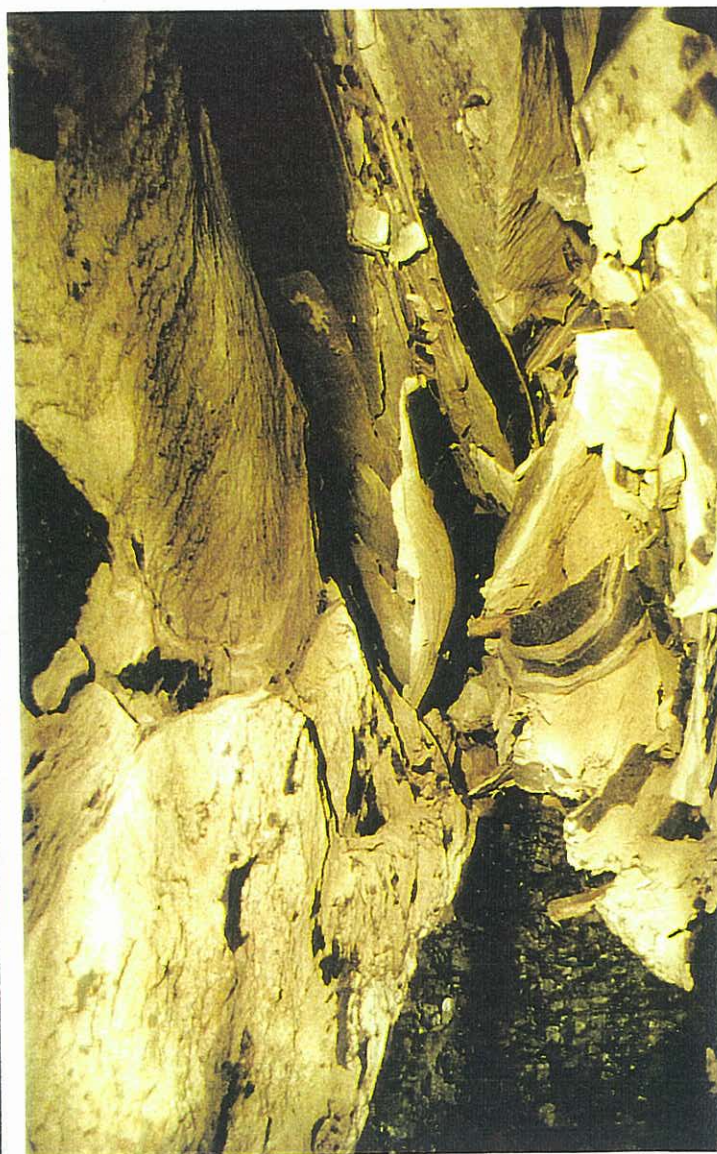
# **Plate I**

Examples of Blue Mountains Colliery  
feather edges in 6 North Panel: top left  
at 18 c/t, top right at 19 c/t, and bottom  
at 22 c/t, showing stepping and low angle  
cave.

Collieries affected by such goaf edge conditions in the recent past and present include the Lake Macquarie (Newcastle) district mines eg. Cooranbong, Wyee and Munmorah and Western Main and Blue Mountains Colliery in the Western Coalfield at Lithgow. The latter colliery provided suitable goaf edge conditions for this study (see Figure 1 for location after Yoo *et al*, 1995). Typical examples of feather edging at Blue Mountains are shown in Plate I.

The props would be completely destroyed or broken. A typical caved edge is shown in Plate I. This would occur in over 90% of goaf falls. The steepest caved edge measured was <50° (down from horizontal).

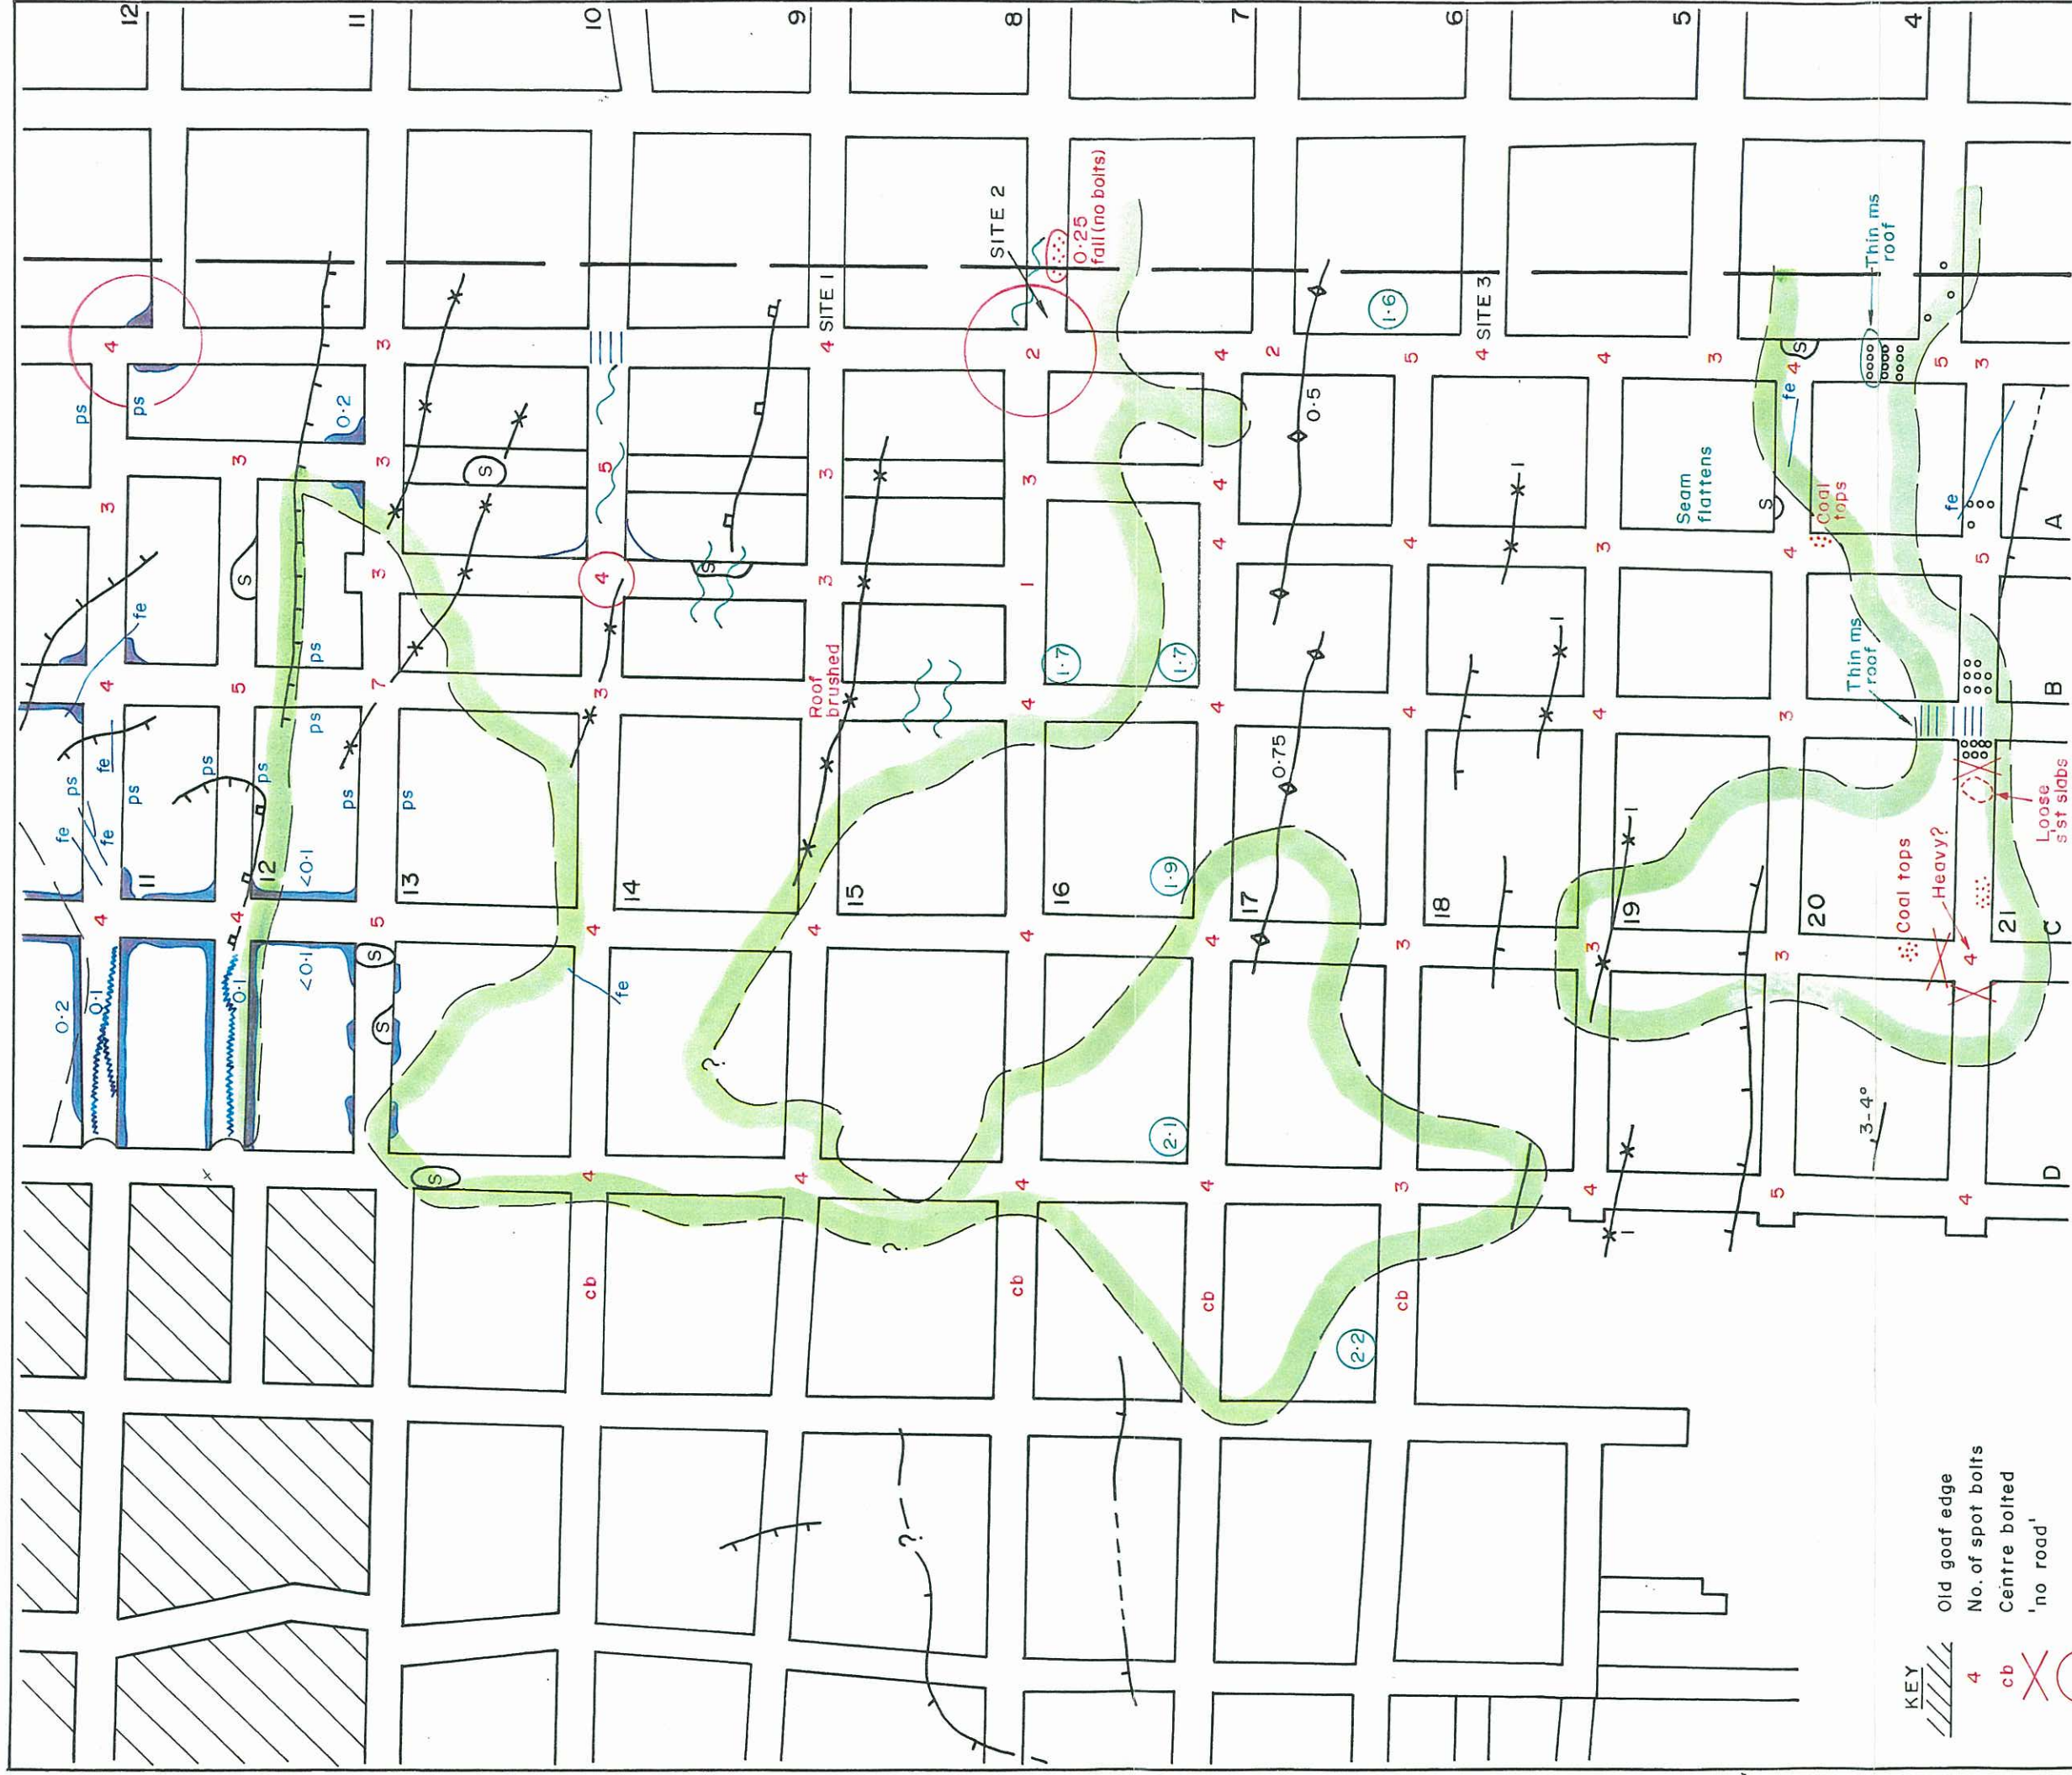
- Old goaf edge
- No. of spot bolts
- Centre bolted
- 'no road'
- Wide span
- Very wide span
- Tell-tale prop
- Stowage
- Seam - steepens
- Seam - reduces dip
- Swilley axis
- 'high' axis
- Floor lift axis crack
- Rib spall (m)
- Patchy spall
- Roof W straps
- Geological feather edge
- Roof rolls
- Measured seam thickness
- Roof irregular surface (in contrast to flat, smooth)

Figure 5 GEOTECHNICAL SKETCH MAP OF STUDY AREA PRIOR TO EXTRACTION

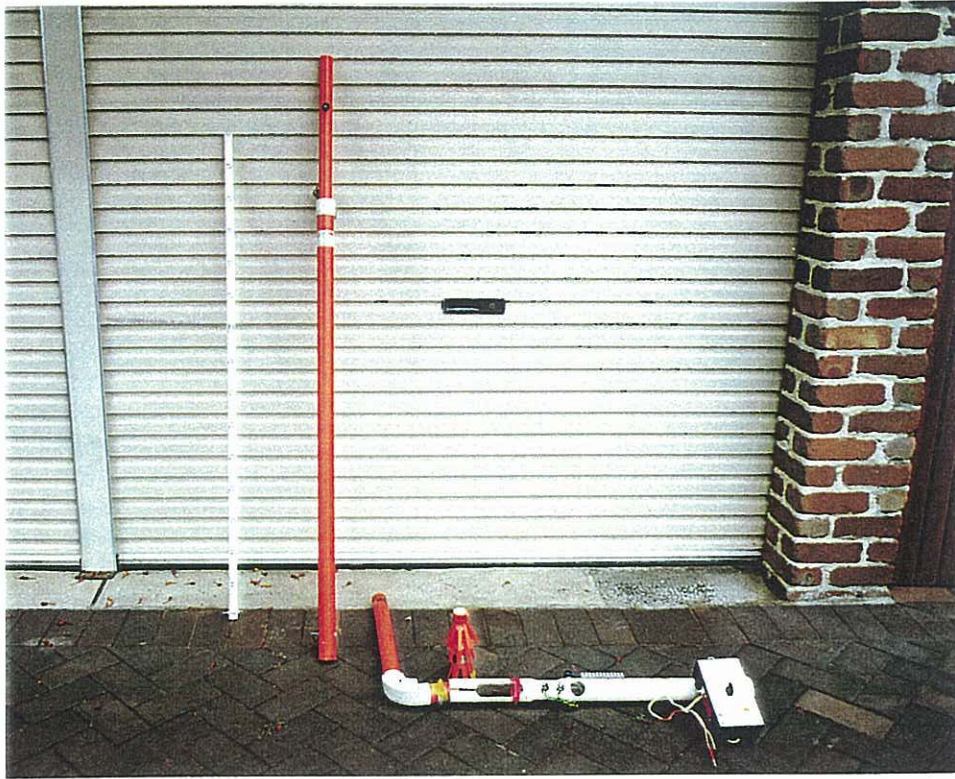
**Plate II**

Instrumentation used: Top left to right, tube shear, convergence rod and resistance wire extensometer; Bottom, SCT instrumented bolt and the readout unit.

Resistance wire units originally developed for goaf edge measurements (Shepherd *et al*, 1990) were used in this study. Lightweight, stainless steel wires are connected to 6 x PVC "shuttlecock" type anchors and at the roof a tubular PVC mount station contains extension springs and 6 x 50k $\Omega$  rotary potentiometers with pulleys. As with the convergence rods, a range of 199 k.ohms and 199mm of travel is attainable with 1mm accuracy.

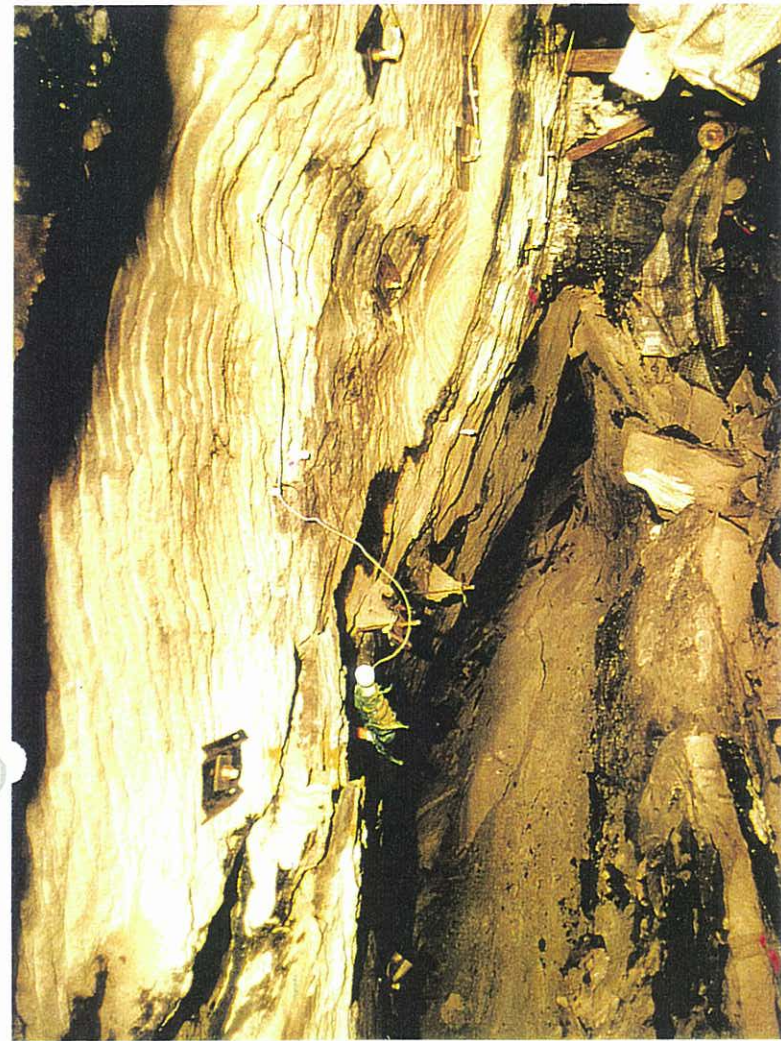
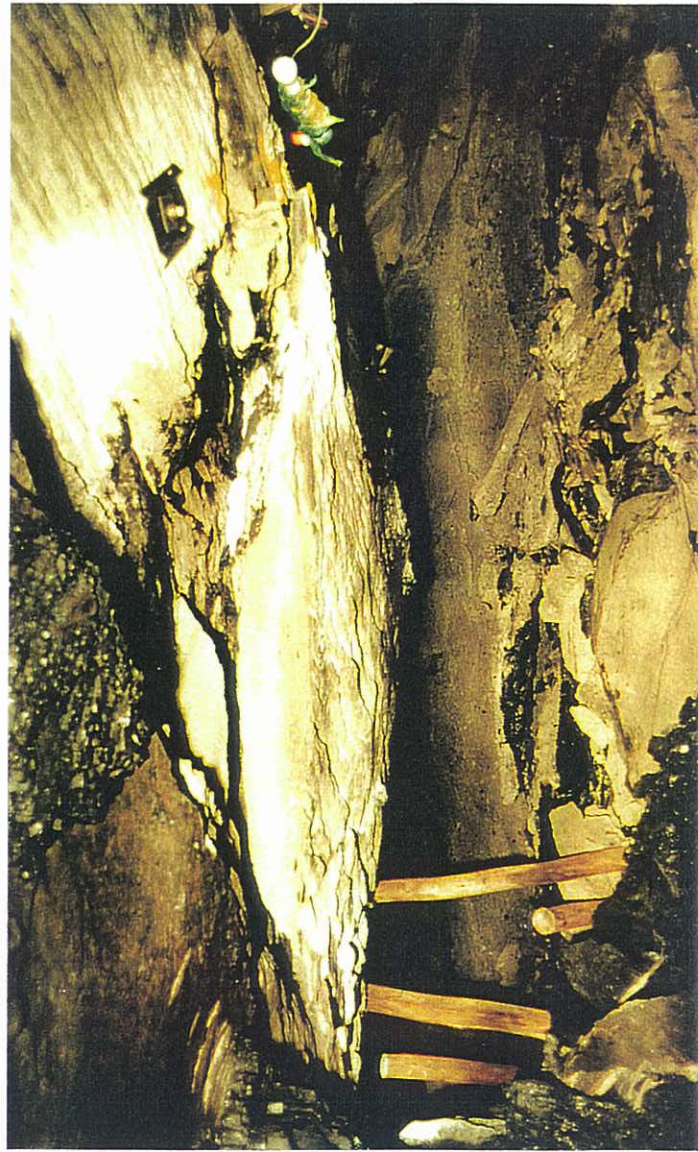
### Plate III

Site 2 feather edge stopped by the bolted breakerline, showing the roof extensometer. Bottom picture shows arch-shaped slab detaching prior to it falling and destroying the extensometer.

This dislodged the site 2 extensometer leaving a lozenge-shaped slab adjacent to it. This device was reset, but the slab detached further damaging it.

As at site 1, this extensometer recorded zero displacement before it was damaged.

When the feather edge caving occurred (as discussed in 7.3), as the third event leading to goaf roof failure, the low angle fractures stopped exactly at the first row of bolts (instrumented) and the roof and breaker props behind them remained in good condition (see Plates III and V).

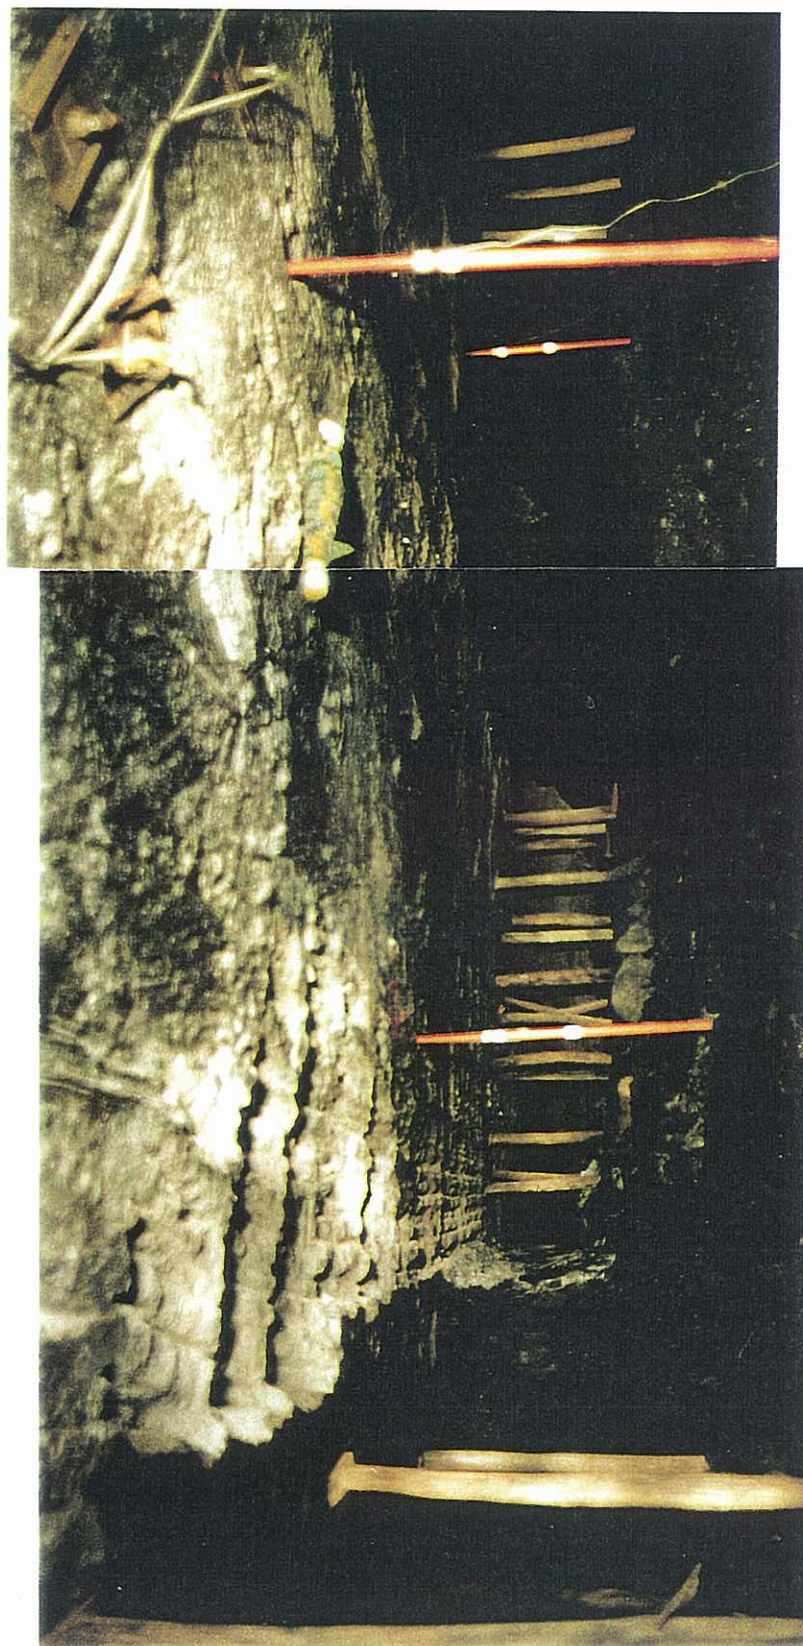
Plate IV

Site 3 before the goaf fall and weekend break, showing convergence rods installed. the goaf edge is behind the breaker props, one pillar distant.

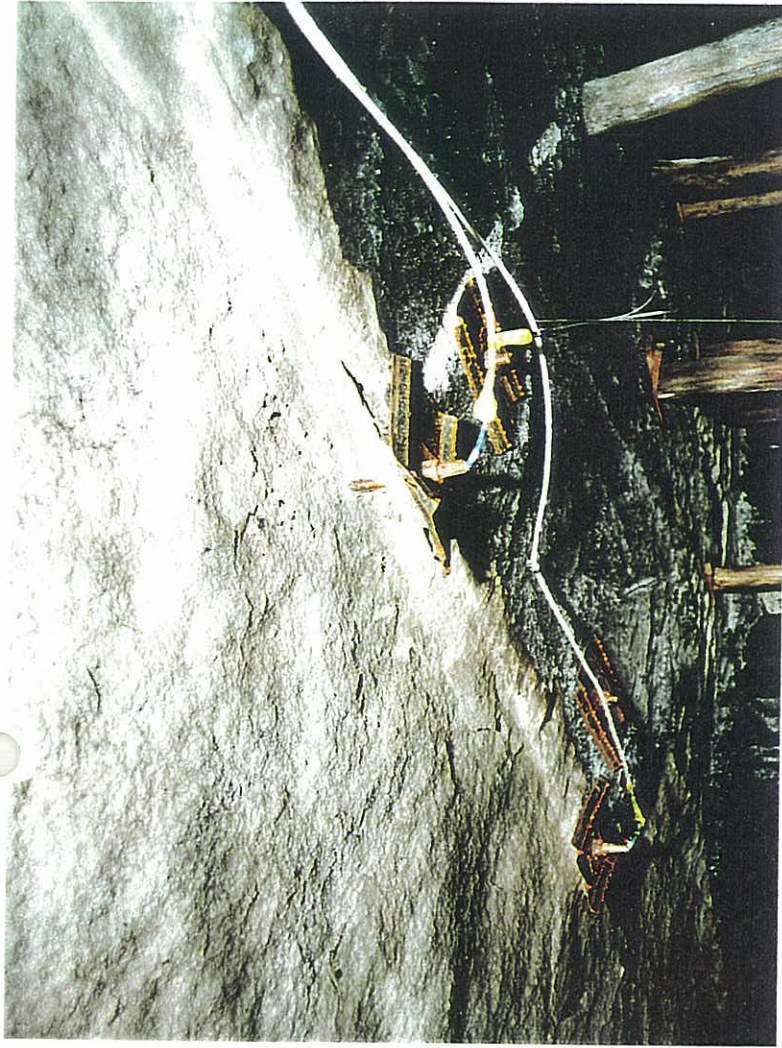
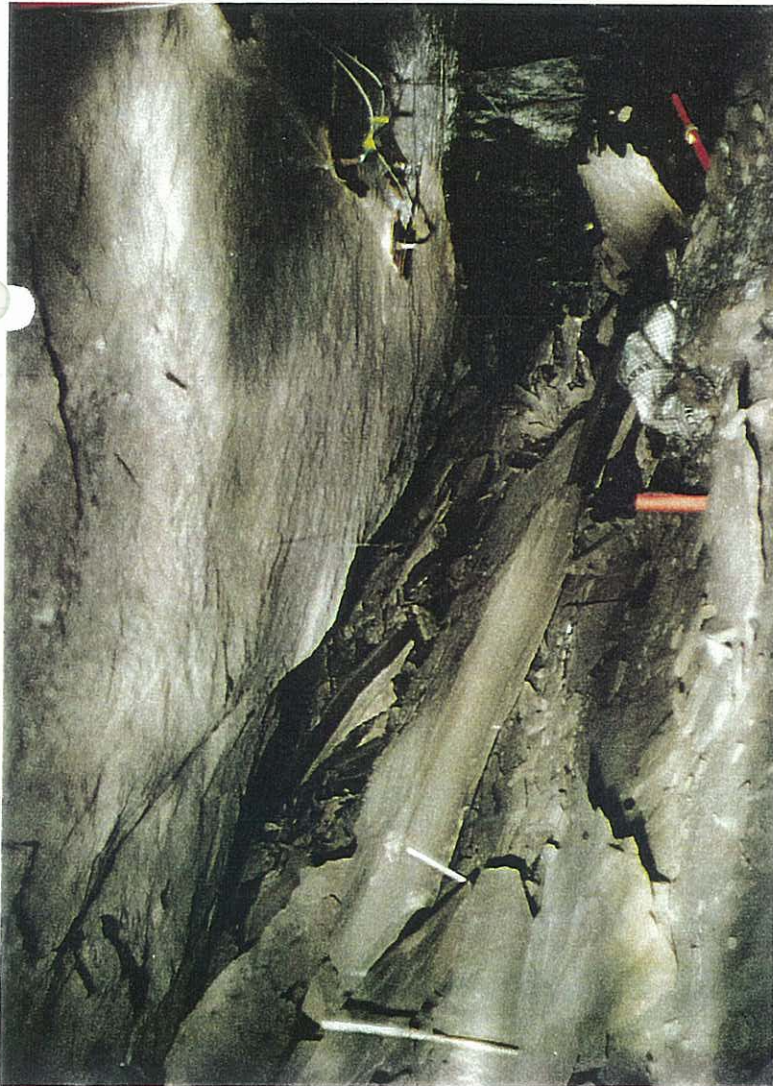
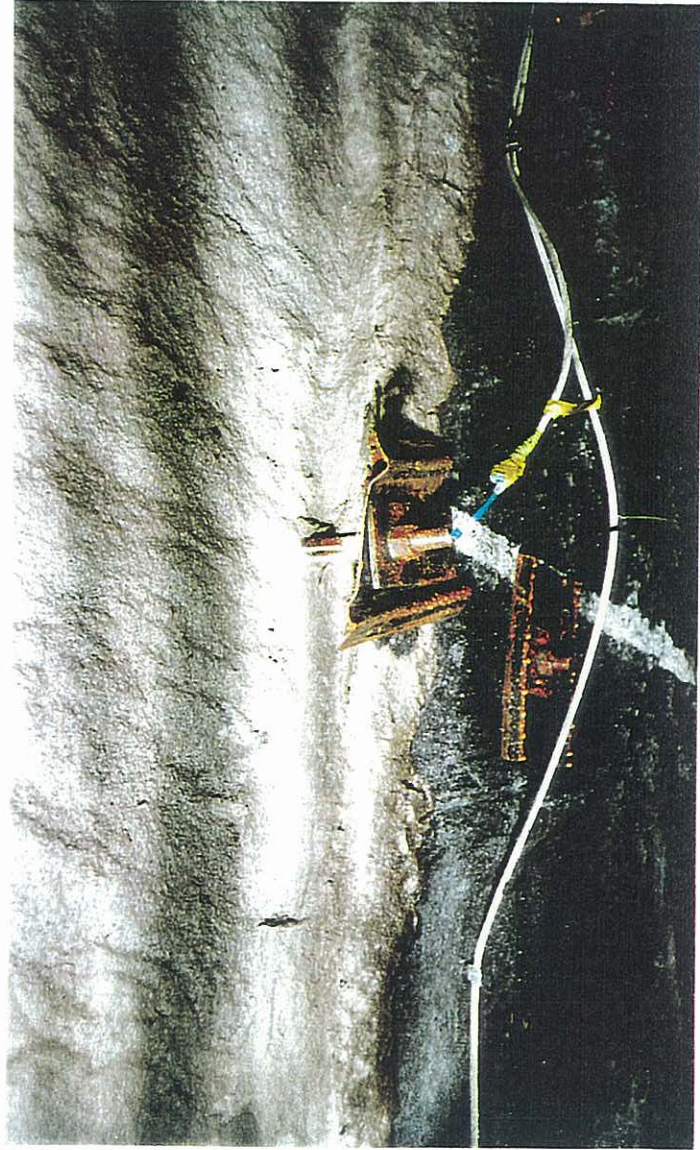
# **Plate V**

Site 3 after weekend goaf fall: top left is low angle cave stop at the bolts line. Remains of extensometer and two tube shears are visible. Top right and bottom show details of the feather edge at the bolts and exposed resin of the full column grout.

The feather edge goaf was stopped at the bolted-line as shown in Plate V and demonstrated its superior performance compared with props. A general view of the goaf edge and some reset convergence rods is shown in Plate VI. The 4 bolts (#123-#126) gave maximum axial loads of 1.24 tonnes, that is much lower than at site 2. The probable reason for this is that less coal was extracted prior to the goaf falling.

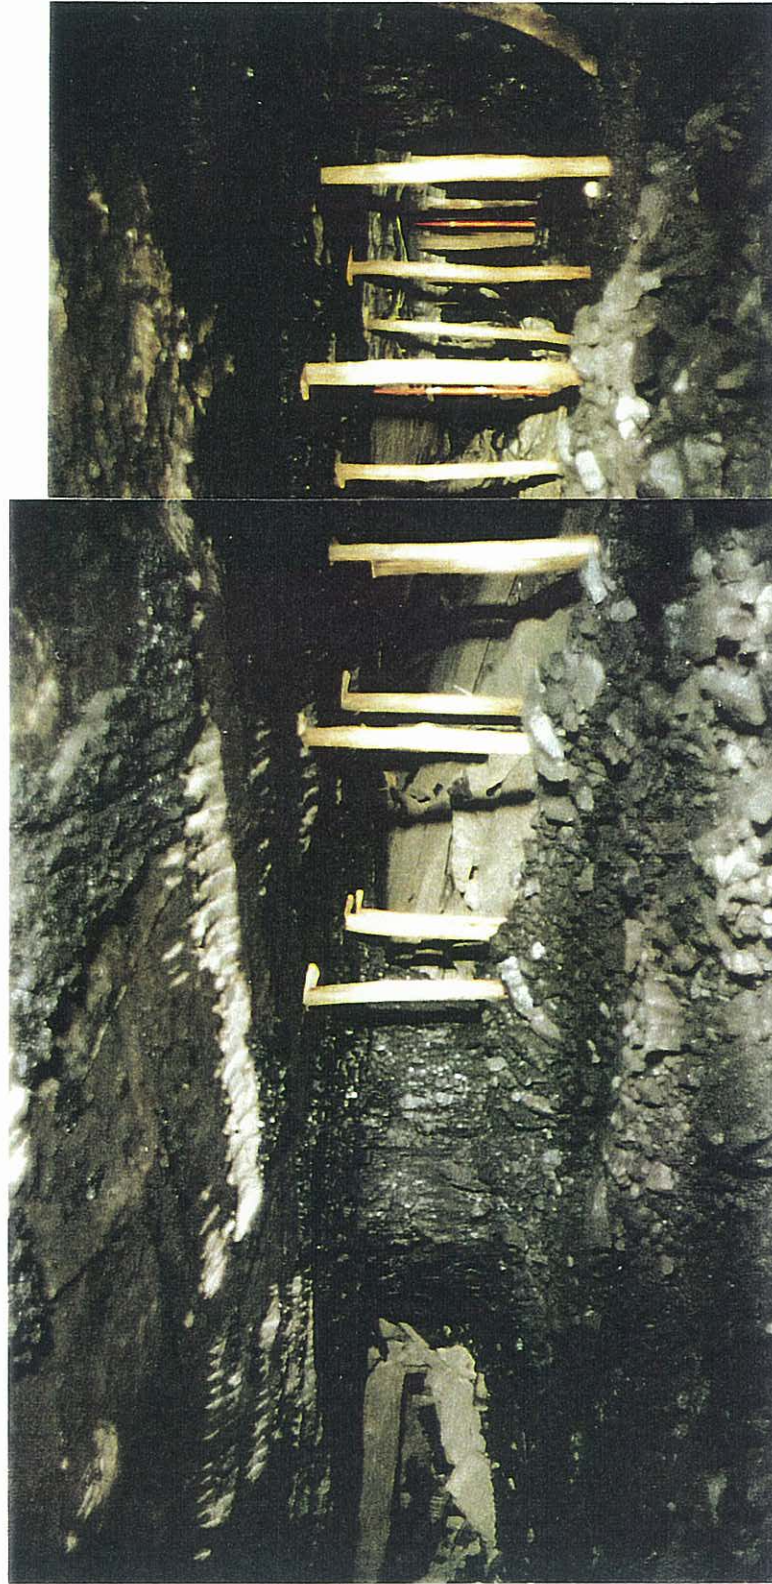
Plate VI

General view of site 3 goaf edge showing the goaf restrained by stook x on the left and the favourable roof conditions immediately outbye.

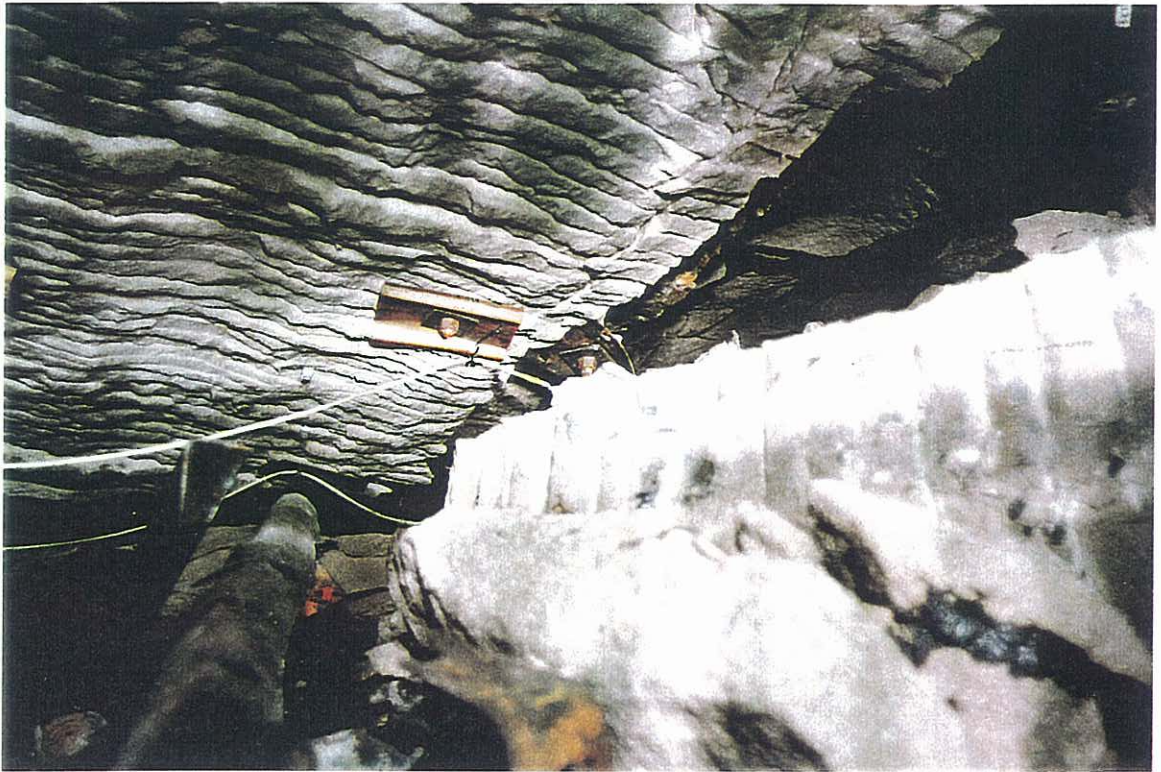
### Plate VIII

Comparison of the goaf edge at 7 and 8 c/ts. Top shows bolted breakerline effect at 8 c/t (site 2) and bottom shows typical feather edge uncontrolled by breaker props at adjacent 7 c/t.

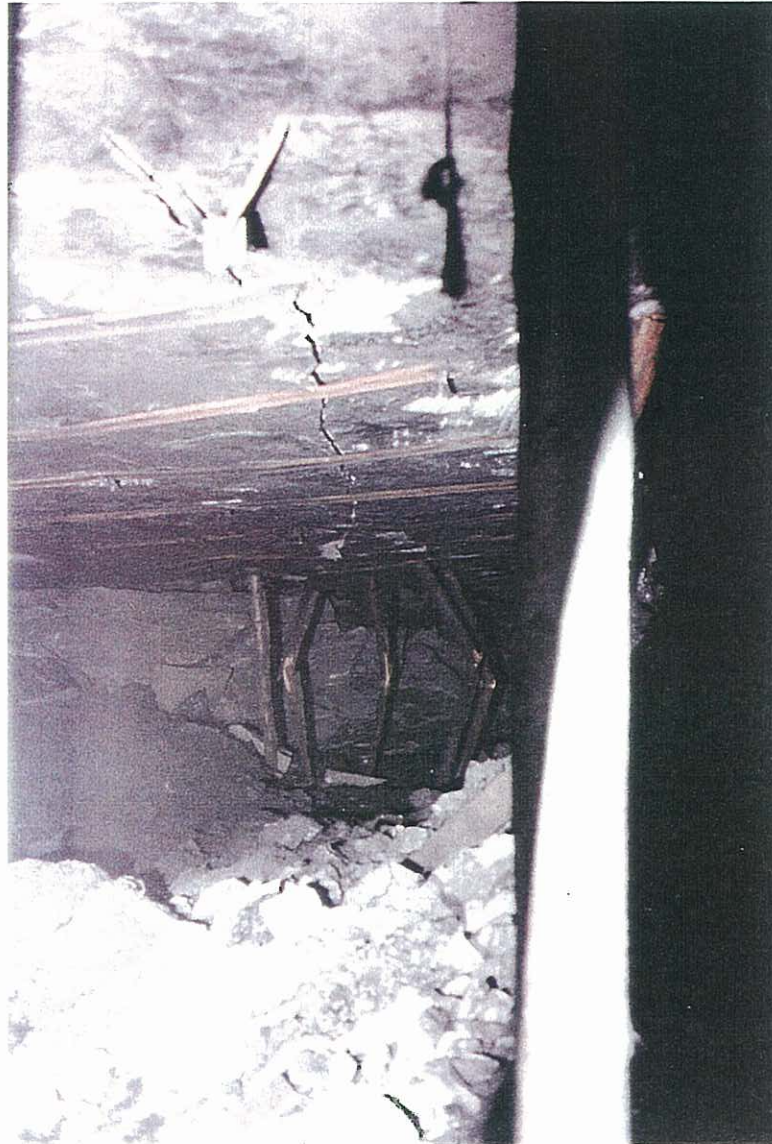
**Plate IX**

Heading axial cracking outbye of a Metropolitan colliery goaf edge in Bulli Seam sandstone roof, similar to the Blue Mountains cracking.

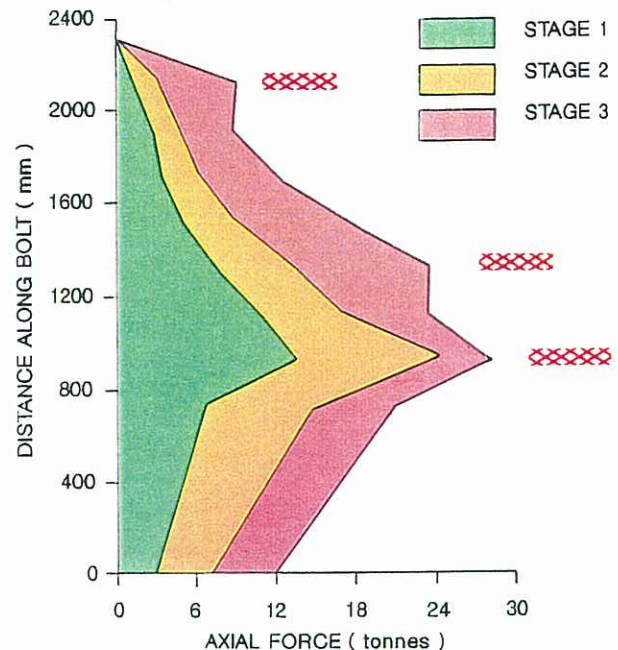
TYPICAL EXAMPLE OF AXIAL FORCES IN A ROOF BOLT MEASURED USING AN INSTRUMENTED BOLT
